<b>REFERENCE:</b>	<b>TSB:</b> 23-048-23 <b>GROUP</b> 23 - Body	<b>Date:</b>	April 22, 2023	<b>REVISION:</b>	—
<b>VEHICLES AFFECTED:</b>	<b>2022 - 2023 (WS) Grand Wagoneer/Wagoneer</b> This bulletin applies to vehicles built on or before <b>October 28, 2022 (MDH 1028XX)</b> equipped with <b>Console Module - Second Row (Sales Code X8K)</b> and without <b>Front Console Cooler (Sales Code XGP)</b> .	<b>MARKET APPLICABILITY:</b> <input checked="" type="checkbox"/> NA <input type="checkbox"/> CH <input type="checkbox"/> EE <input type="checkbox"/> IAP <input type="checkbox"/> SA <input type="checkbox"/> MEA			
<b>CUSTOMER SYMPTOM:</b>	Front And/Or Rear Console/Armrest Lid Not Closing. Lower cover is separating from the lid at the rear.				
<b>CAUSE:</b>	Center console incorrectly assembled.

This bulletin involves possibly re-securing and/or replacing the center console/armrest lower cover.

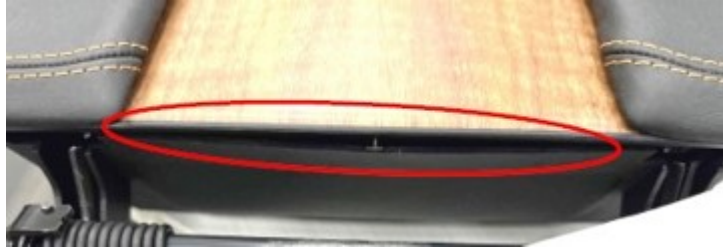
1. Operate both the front and rear seat center console/armrest lid covers.
2. Do either or both of the console/armrest lid covers not close completely as a result of the lower cover(s) separating (Fig. 1) ?
  - YES>>> Proceed to [Step 1](#) of the Repair Procedure.
  - NO>>> This bulletin is complete. Use Inspect LOP (23-14-08-90) to close this active RSU.

**Fig. 1**  
**Console Lower Cover Separating**

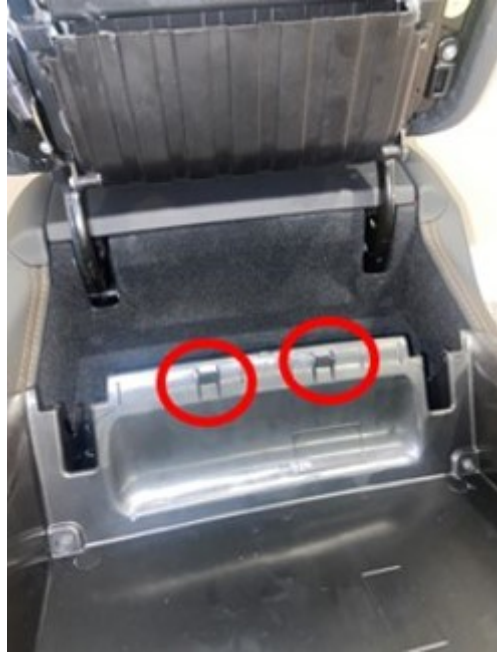
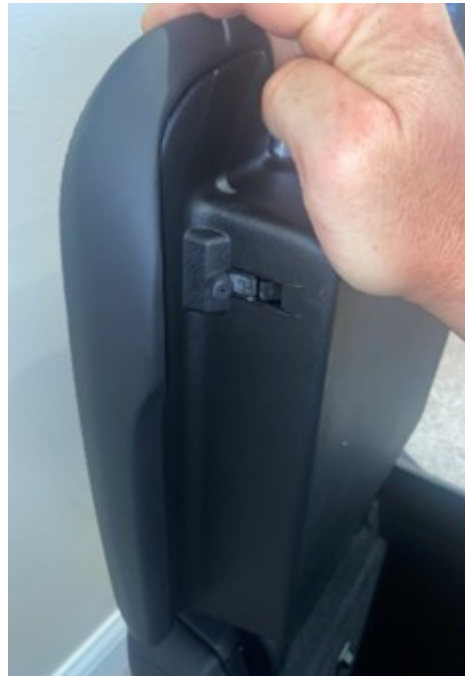
**Fig. 4**  
**Molded Hooks**

**Fig. 5**  
**Top Clips**

3. Re-attach armrest lower cover. Start at bottom to ensure molded hooks are engaged before clipping in top clips (Fig. 4) , (Fig. 5) .
