REFERENCE:	TSB: 23-046-23 GROUP 23 - Body	Date:	April 25, 2023	REVISION:	-
VEHICLES AFFECTED:	2022 (WS) Grand Wagoneer/Wagoneer This bulletin applies to vehicles built on or after August 01, 2022 (MDH 0801XX) and on or before November 29, 2022 (MDH 1129XX).	MARKET APPLICABILITY:			
CUSTOMER SYMPTOM:	<p>Customers may experience one or more of the following:</p> <ul style="list-style-type: none"> Fuel door won't open or is stuck closed. Tabs holding the actuator which provide the push to open function on the fuel door have broken (Fig. 1) . 				
CAUSE:	Design issue.

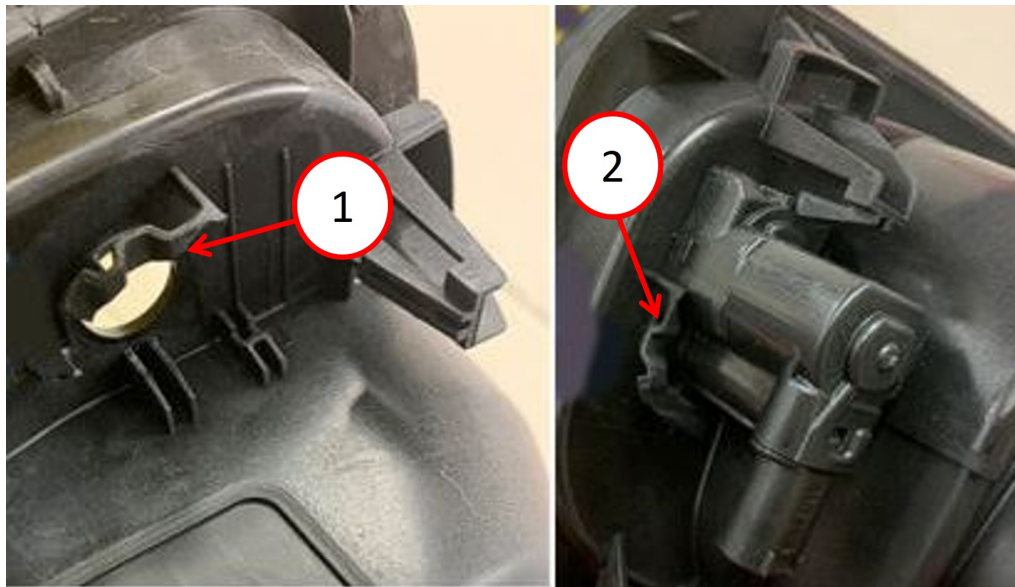
Fig. 1
Fuel Filler Door Housings

- 1 - Broken Housing Tabs NOT Holding Actuator
- 2 - Housing Tabs Holding Actuator

This bulletin involves replacing the fuel filler door housing.

1. Replace the fuel filler door housing. Refer to the detailed service procedures available in DealerCONNECT> Service Library under: Service Info>23 - Body / Exterior / Housing, Fuel Fill / Removal and Installation.
