Technical Service Bulletin (TSB)  
Trim Panel on the Back of the Front Seats is Warped

<b>REFERENCE:</b>	<b>TSB:</b> 23-043-23 <b>GROUP</b> 23 - Body	<b>Date:</b>	April 7, 2023	<b>REVISION:</b>	-
<b>VEHICLES AFFECTED:</b>	<b>2022 - 2023 (WD) Dodge Durango</b> This bulletin applies to vehicles built on or after May 17, 2022 (MDH 0517XX) and on or before October 24, 2022 (MDH 1024XX).	<b>MARKET APPLICABILITY:</b>			
		<input checked="" type="checkbox"/> NA	<input type="checkbox"/> CH		
		<input checked="" type="checkbox"/> EE	<input type="checkbox"/> IAP		
		<input checked="" type="checkbox"/> SA	<input checked="" type="checkbox"/> MEA		
<b>CUSTOMER SYMPTOM:</b>	The trim panel on the back of one, or both, front seats is warped.				
<b>CAUSE:</b>	Clips not being fully engaged.

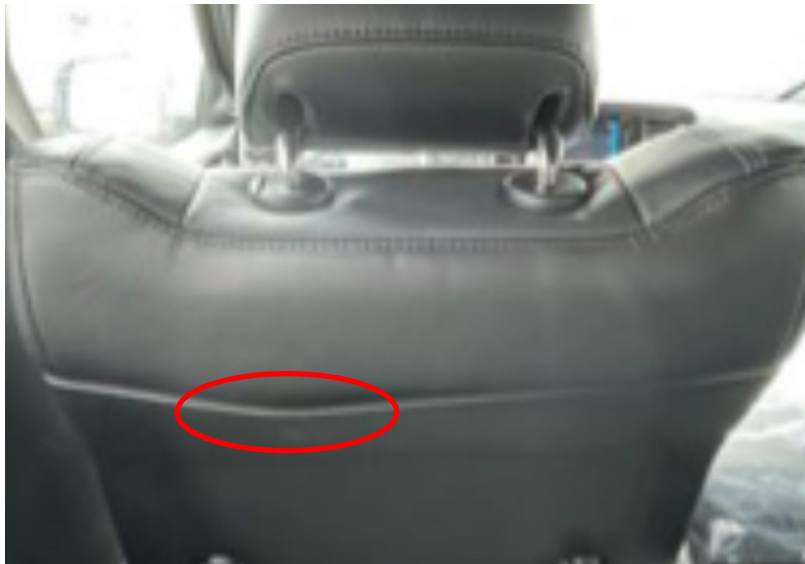
1. Visually inspect both front seat back panels for a warpage (Fig. 1) .

**Fig. 1**  
**Warped Front Seat Back Panel**

1. Replace the front seat back panels as required. Refer to the detailed service procedures available in DealerCONNECT> Service Library under: Service Info> 23 - Body / Seats / Panel, Seat Back, Front / Removal / Installation.
