UPDATE FROM WARRANTY OPERATIONS

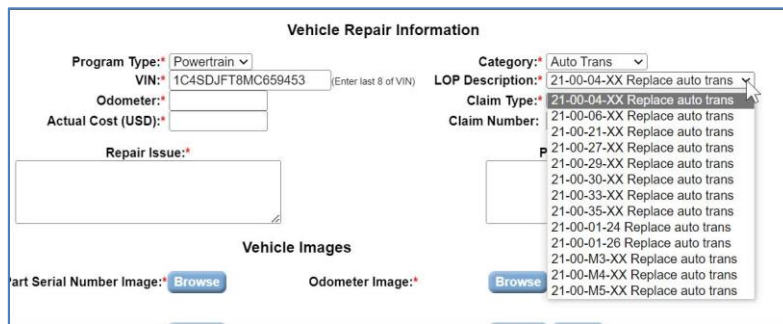
Sample of DealerCONNECT LOP tree showing correct LOP is 21-00-60

Drop down menu missing LOP (Use 21-00-06)

available in the Pre-Authorization drop-down, please use the closest LOP from the drop-down menu.

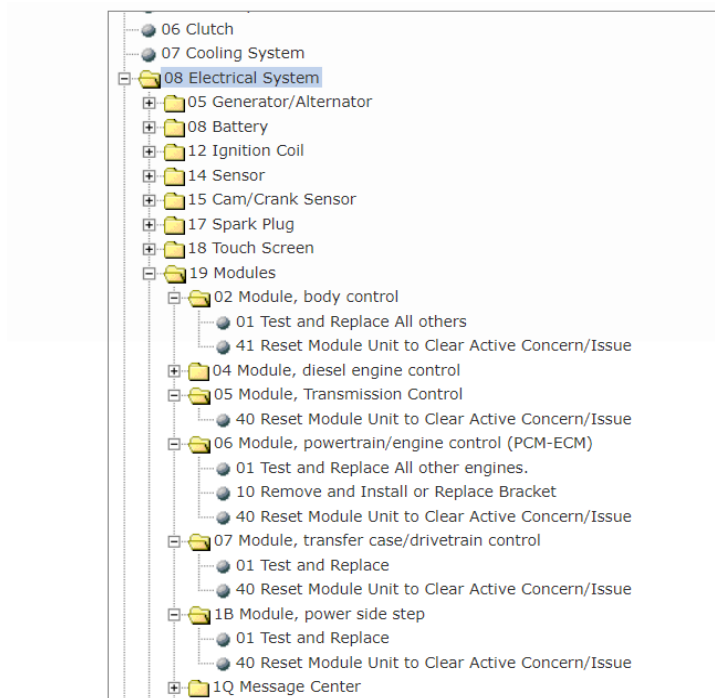
In the interest of clarifying the proper LOP to use for a Module Reset, we have created a new LOP (08-19-XX-40) - "Reset Module Unit to clear active Concern/Issue" (see screen print below). This LOP should be used when there is a customer concern that has been verified and

is corrected by a Module Reset. This should be used *before* replacing any module. If there is no actual verified concern, the diagnostic LOP 85-41-XX-XX "No Trouble Found" (for the appropriate Area) should be used, even if a Module reset is performed.

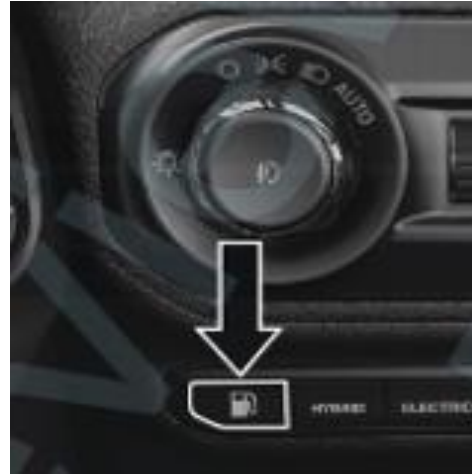
We are finding corrosion in the electrical connectors for the Jeep Wrangler (JL) PHEV versions. The Fuel Filler Door has an electrical release that includes an electrical actuator to open the Fuel Filler Door. The release button (located below the headlight switch) is shown in the photo on the right.

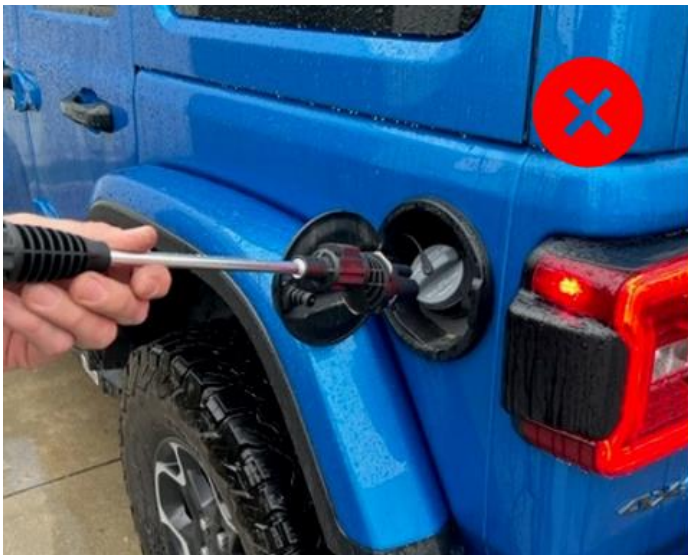
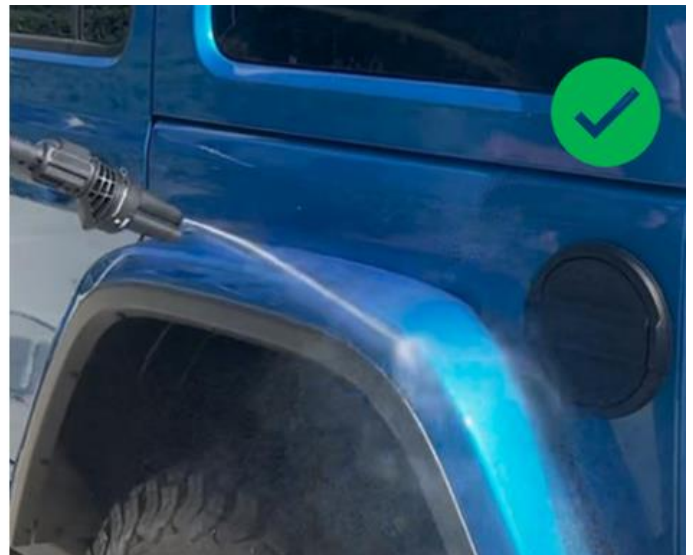
It is very important to not use a high-pressure water spray in the open fuel door, as this can cause water to damage the Door Actuator

electrical connections and lead to an issue with the Fuel Filler Door operation.

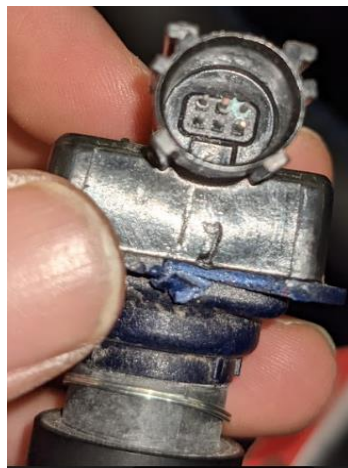
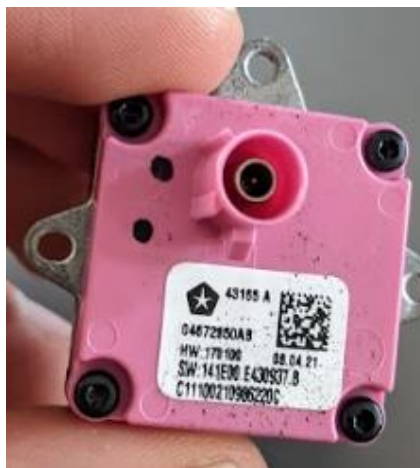
Analog and digital cameras can be identified by the type of connector they have.

Analog is seen on the left and digital is on the right.

When inspecting a camera for a blurry image, verify that the lens does not have any scratches and has been cleaned. Also, verify if the camera is an analog or digital. Analog cameras have a much lower quality image compared to newer digital cameras and the customer may believe the image is blurry due to the limitations of the camera itself. Replacement of a blurry analog camera will most likely not improve the image quality and

When testing for a blurry image, ensure the lens is clear of scratches/debris and make sure to examine the image in an indoor setting. Analog cameras may show a degraded image in certain lighting environments.

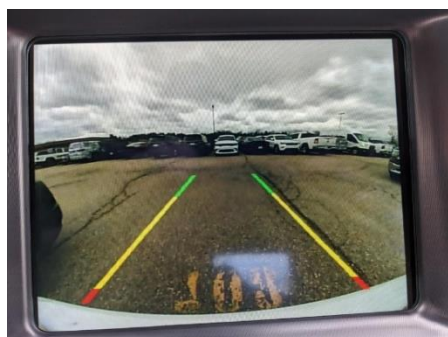
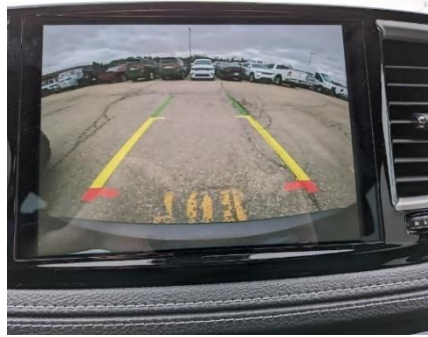
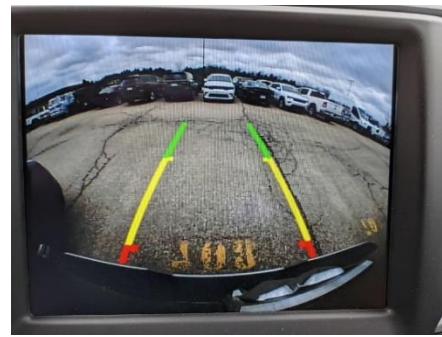
The quality of the image may vary in different vehicles.

Below is a range of images that we currently expect from an analog camera.

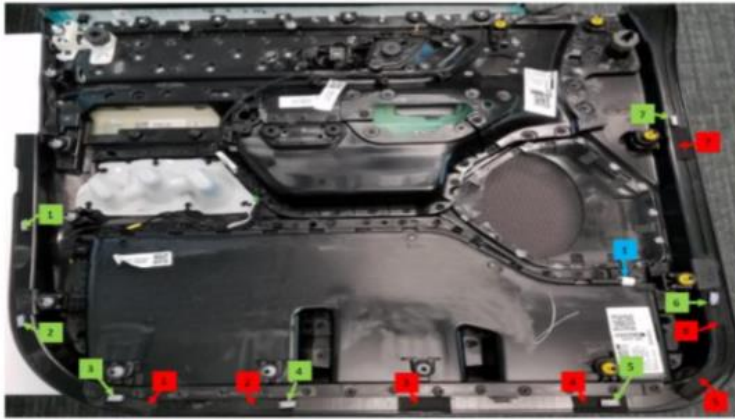
Door Clip Locations

We have seen several speakers returned that test perfect when tested. When experiencing audio BSR issues, check the clips on the door

trim panels, foam replacements, window cables and the plastic on the sheet metal for issues before replacing speakers.

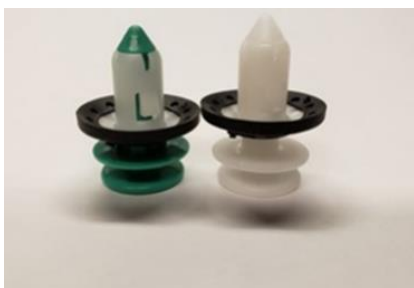
Please use care when removing the door trim for speaker retention. Check that the white clips are the ones being used. Production is no longer using green clips. If green clips are found, replace the green clips with the new white clips, as that is the most likely cause of the BSR the customer experiences. (Figure 1)

Figure 1. Green vs White Clips

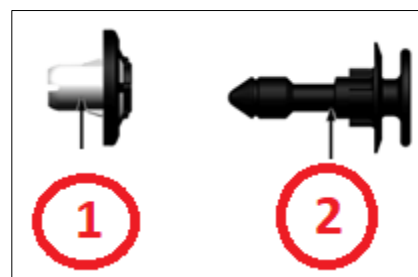
Through testing, we have determined that improper clip placement was causing buzzes, rattles, and crackles in the door trim. When removing the trim, the two-stage clip can come off with the inner and outer piece. (Figure 2)

Figure 2. Two stage clips
