## Technical product information

<b>Topic</b>	Bentayga - Fuel Gauge - Guided Fault Finding DTC's B103E1B and/or B10581B evident within address 0046
<b>Market area</b>	Russische Föderation (5RU),Australia E04 Bentley rest Asia and Australia (6E04),China 796 VW Import Comp. Ltd (Vico), Beijing (6796),Germany E02 Bentley rest Europe (6E02),Japan E03 Bentley Japan (6E03),Korea, (South) E08 Bentley South Korea (6E08),United Arab Emirates E06 Bentley Middle East and Africa (6E06),United Kingdom E01 Bentley UK (6E01),United States E05 Bentley USA and rest America (6E05)
<b>Brand</b>	Bentley
<b>Transaction No.</b>	2060081/3
<b>Level</b>	EH
<b>Status</b>	Approval
<b>Release date</b>

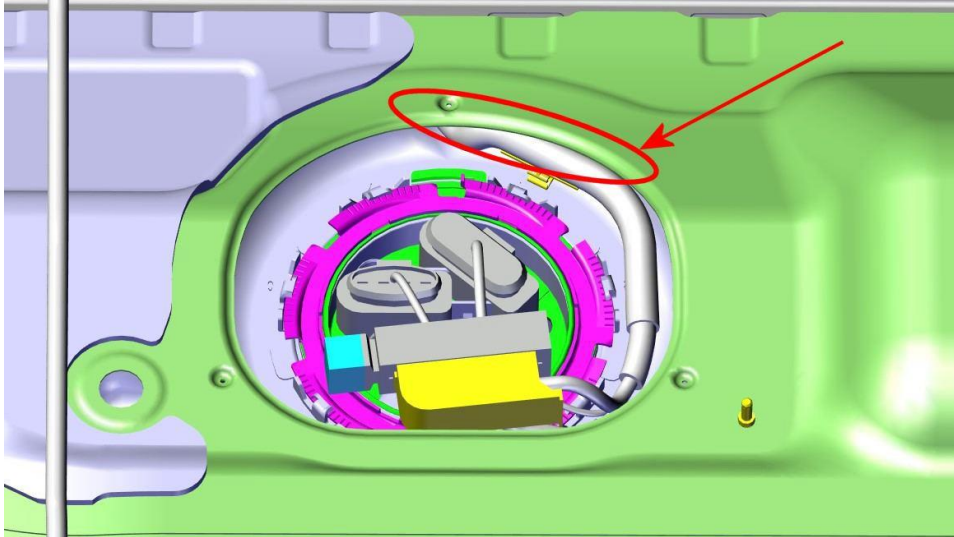
- Referring to Figure 5 – Conduct a check of the wiring harness to confirm if any damage is evident

Should any issues be found regarding wiring harness damage – The operative must raise a new DISS query or update the already existing query ensuring photographs of the issue and a description of the damage is included
