Technical product information

Topic	Rear doors do not fully open (Left and/or Right)
Market area	Russische Föderation (5RU),Australia E04 Bentley rest Asia and Australia (6E04),China 796 VW Import Comp. Ltd (Vico), Beijing (6796),Germany E02 Bentley rest Europe (6E02),Japan E03 Bentley Japan (6E03),Korea, (South) E08 Bentley South Korea (6E08),United Arab Emirates E06 Bentley Middle East and Africa (6E06),United Kingdom E01 Bentley UK (6E01),United States E05 Bentley USA and rest America (6E05)
Brand	Bentley
Transaction No.	2068866/2
Level	EH
Status	Approval
Release date

Bentayga EWB

Rear doors do not fully open (Left and/or Right)

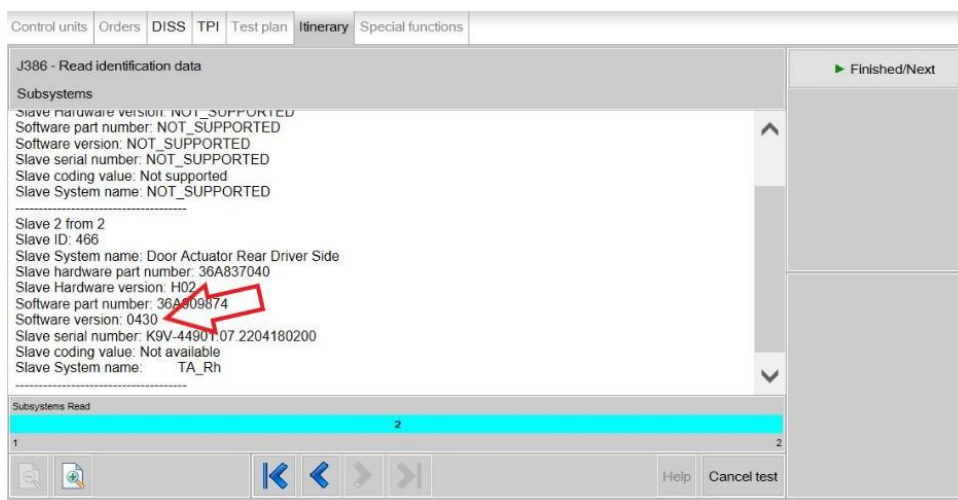
Figure 1

In the event the Software version is 0430 (Figure 1) the operative MUST raise a Technical DISS query stating the following:

- The Software version of J386 and J387 is 0430
