## Technical product information

<b>Topic</b>	Front centre console lid (cup holder assembly) fails to latch
<b>Market area</b>	Bentley: worldwide (2WBE)
<b>Brand</b>	Bentley
<b>Transaction No.</b>	20519377
<b>Level</b>	EH
<b>Status</b>	Approval
<b>Release date</b>

Front centre console lid (cup holder assembly) fails to latch

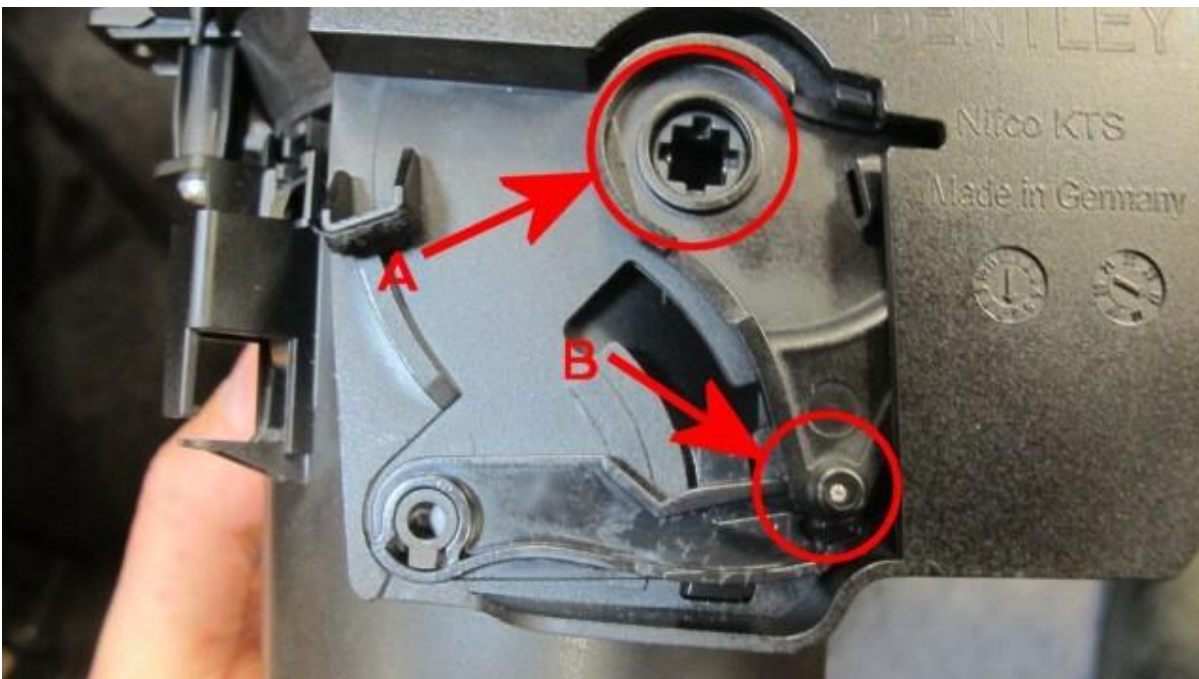
Figure 3

**IMPORTANT NOTE:** When carrying out the remainder of the procedure ensure that the components mentioned are not forced or twisted as this can damage the mechanism which will result in cup holder assembly replacement

- Referring to Figure 3, Dislodge/manoeuvre the lid drive (Point A) from its upper axis
- Carefully disengage the lid drive locating peg (Point B) out and away from the pawl

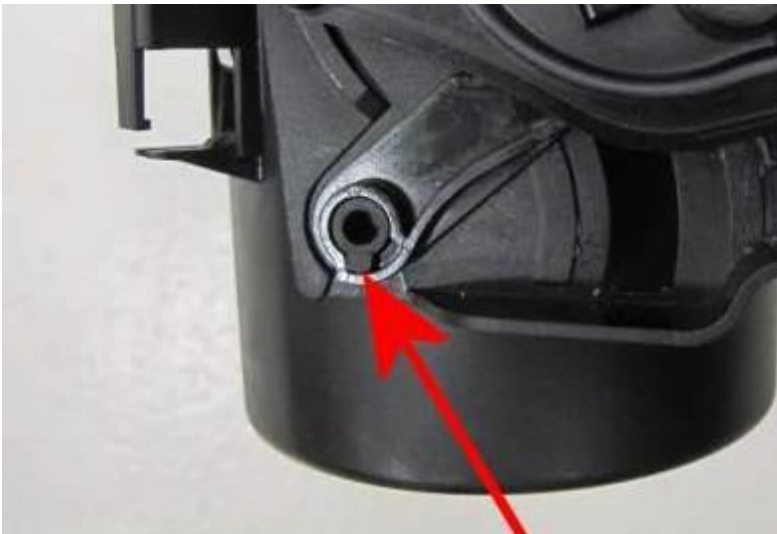
Referring to Figure 5 ensure the pawl is positioned exactly as shown, **Do Not** attempt removal of the pawl from the lower axis unless in the position shown as the location tang can break

- Once the location is confirmed with extreme care and using a suitable flat headed tool, remove the pawl from the lower axis and discard as per local environmental guidelines
