Technical Service Bulletin

91 USB Interface: USB socket lose, missing, pushed in

91 23 96 2066315/2 May 17, 2023. Supersedes Technical Service Bulletin Group 91 number 22-87 dated March 7, 2022, for reasons listed below.

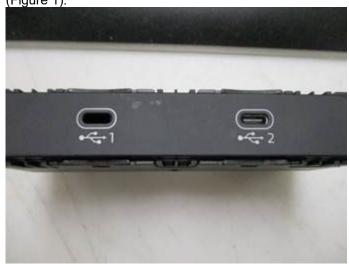
- One or both of the USB sockets in the USB interface assembly is either loose or pushed back into the housing.
- One or both of the USB sockets in the USB interface assembly is sheared off the Printed Circuit Board (PCB) (Figure 1).

Figure 1: USB socket sheared off the PCB and loose in the housing.

- If the USB connector is improperly inserted into the USB socket (for example, at an angle).
- If excessive force is applied when inserting the USB connector into the socket.
- If a non-USB-standard compliant USB connector or cable is used (e.g. low quality cables that are available online might not be USB-standard compliant in regards to connector size and damage the USB socket).
- Certain "prank" (USB-killer) devices can destroy the internal electronics of the USB interface.

The USB interface will need to be replaced to restore function.
