Technical Service Bulletin

93 Update OBC software when replacing HV wiring harness for charging socket

93 23 05 2070110/2 May 8, 2023. Supersedes Technical Service Bulletin Group 93 number 23-03 dated April 25, 2023, for reasons listed below.

Model(s)	Year	VIN Range	Vehicle-Specific Equipment
e-tron quattro	2019	All	Not Applicable
e-tron Sportback quattro	2020

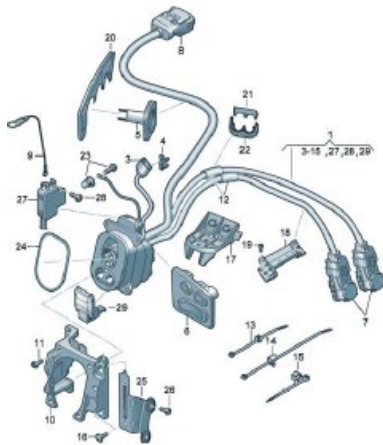
The High Voltage Wiring Harness for the charging socket UX4 or UX5 is replaced as part of any repair work (Figure 1).

Figure 1. High-voltage wiring harness for charging socket.

If the high-voltage wiring harness for the charging socket is replaced as listed in Table 1.2, an SVM code will need to be performed *and a replacement test plan performed*.
