### 97 Diagnostic tester does not communicate with vehicle via OBD socket - contacts widened

97 23 94 2070383/1 May 19, 2023.

Model(s)	Year	VIN Range	Vehicle-Specific Equipment
A4 allroad, A4, S4, A5, A5 Cabriolet, A5 Sportback, S5, S5 Cabriolet, S5 Sportback, RS 5, and RS 5 Sportback	2023	All	Not Applicable

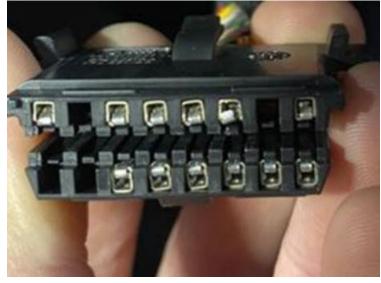
Contacts on diagnostic connection U31 are damaged.

Pins within the OBD port U31 (Figure 1) may have been damaged in production.

Figure 1: OBD port (U31).

Check contacts on diagnostic connection for damage.

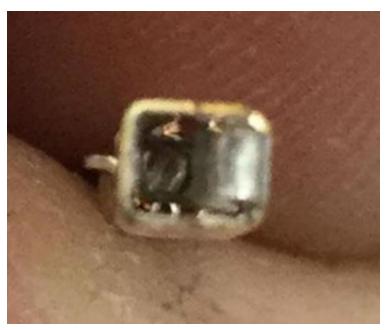
Contacts on the diagnostic connection (OBD socket) may have been damaged in the production process.

Figure 2: Damaged pin.

Repair the wires as needed using VAS 1978 B
