Subject: The improvement of the noise insulation  
at the front door zone

Bulletin Nu: TS30-FC-2208

Araç Modeli: TS30 EPA21

This service bulletin describes the application of the precaution of the noise which comes from the front door of the vehicle.

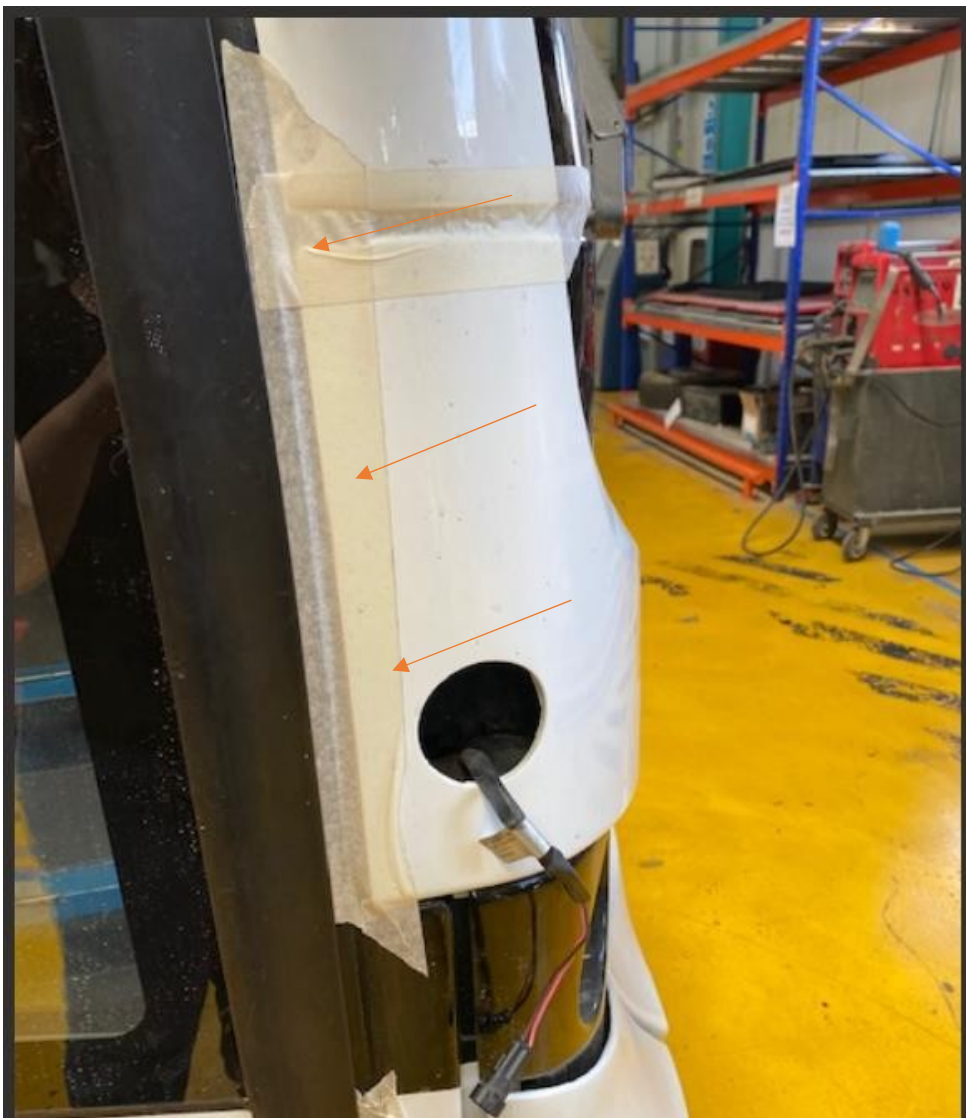
**Figure.1** The view of application zone

1. This zone is between the end of the front mask and the beginning of the door frame as shown in Figure.1. The air flows and make noise through this zone. So, this gap behind the door frame needs to be closed.
2. The front mask is taken out and the sealer which is written in Table.1 is applied to this gap until the finish line of door frame appears. This side and front view of the area where the sealer is applied shows in Figure.2 and Figure.3, respectively.
