**Accord CAN Gateway Errors DTC U1803-88 and Code TT06**

**AFFECTED VEHICLES**

Year	Model	Trim Level	VIN Range
2023	Accord Hybrid	ALL	ALL
2023	Accord	ALL	ALL

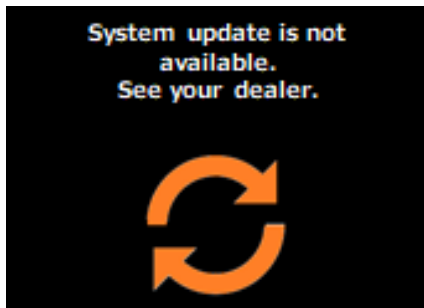
In all trims, the message below appears in the Meter. When i-HDS is used to perform an **ALL DTC Scan**, the DTC U1803-88 will be returned.

A software issue is causing an internal Ethernet error in the CAN Gateway Unit (CGW).

Restart the Over the Air (OTA) System, then update the CGW to the latest software version.

If the software is up to date, and the code reappears, follow the trouble shooting steps for **DTC U1803-88**.

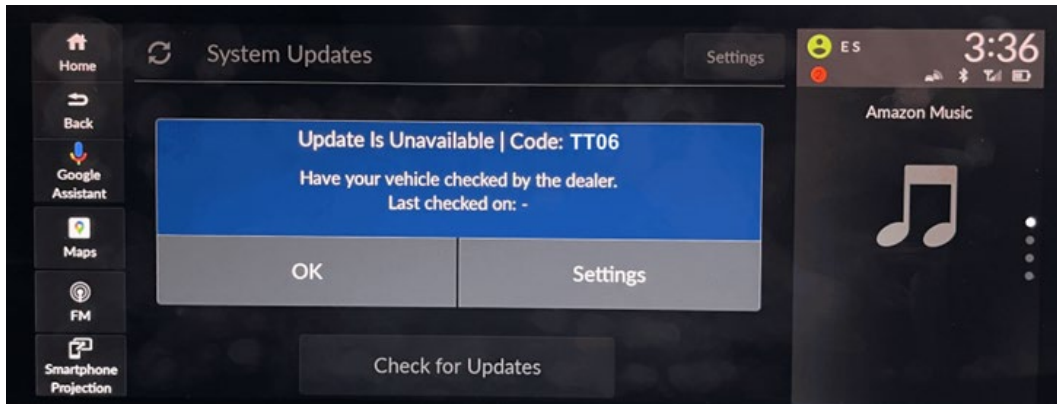
In Hybrid trims, the audio unit may also display Code TT06.
