GROUP	MODEL
ELE	2016-2018MY Sorento (UMa)
NUMBER	DATE
297	May 2023

## TECHNICAL SERVICE BULLETIN

## MULTIFUNCTION SWITCH REPAIR

This bulletin provides information associated with the 'Multifunction Switch Warranty Extension Program' (WTY031) to repair the multifunction switch knob on 2016-2018MY Sorento (UMa) vehicles, produced at Kia Georgia from October 27, 2014 through March 7, 2018, which may exhibit an intermittent headlamp flickering. The vehicle's warranty for this issue will be extended from 5 years/60,000 miles to 15 years/150,000 miles, whichever comes first, starting from the date the vehicle was first put into service. Follow the procedure outlined in this publication to replace the multifunction switch moving block and outer cover with the new improved part.

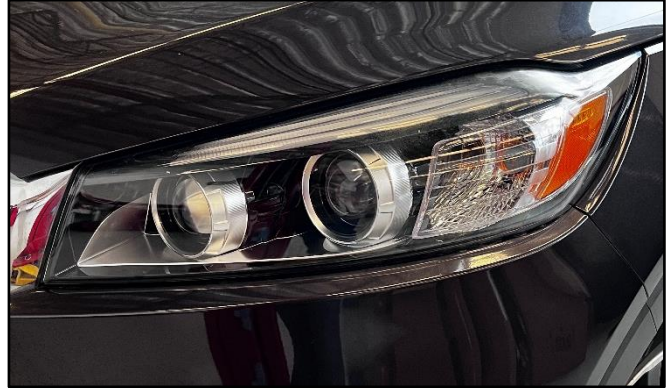
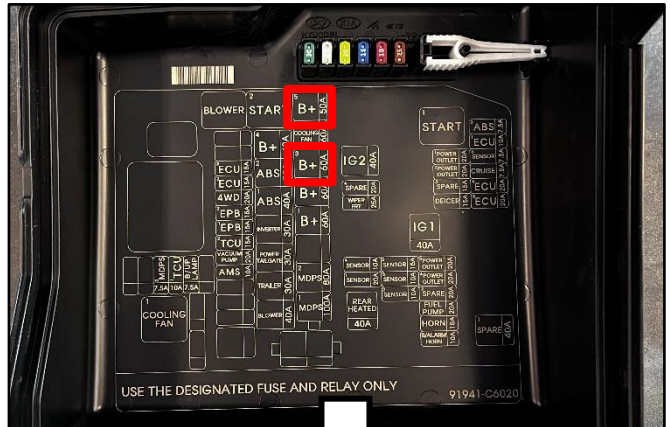
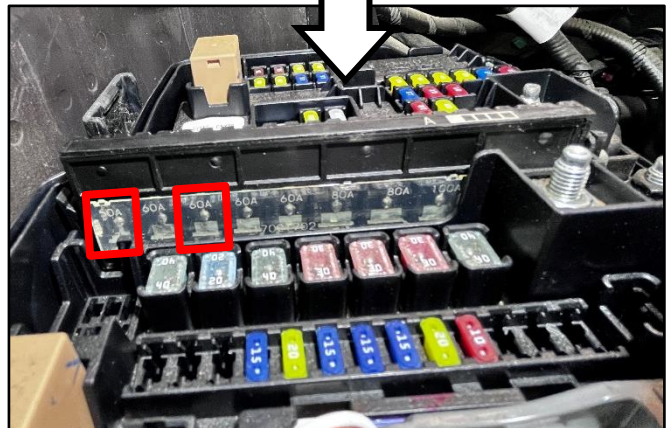
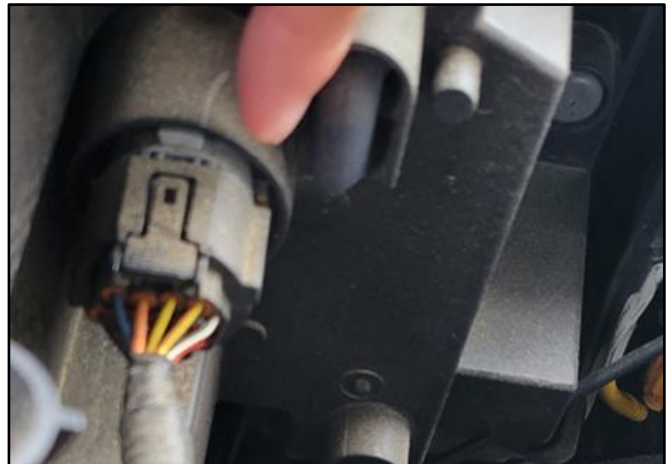
1. Perform a visual inspection of the bulb.
  - If the bulb is **(OK)**, continue to step 2.
  - If the bulb is **(NG)**, this TSB does not apply. Claim Diagnosis Op Code **232A10IO**.

2. Ensure the 50A B+5 and 60A B+3 headlamp fuses are not blown.
  - If the fuses are not blown **(OK)**, proceed to step 3.
  - If the fuses are blown **(NG)**, this TSB does not apply. Claim Diagnosis Op Code **232A10IO**.

3. Ensure the headlamp connector is properly seated.
  - If the connector is properly seated **(OK)**, proceed to the 'Repair Procedure'.
  - If the connector is not properly seated **(NG)**, remove connector and properly install. No further action required. Claim Diagnosis Op Code **232A10IO**.
