Accord CAN Gateway Errors DTC B2B05-92 and Code K201

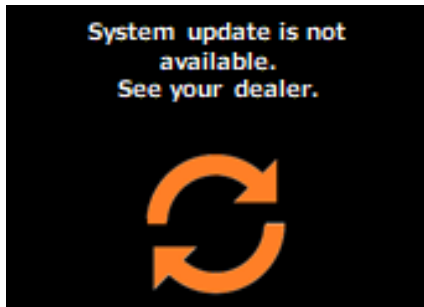
In all trims, the message “System update is not available. See your dealer” may appear in the gauge. When i-HDS is used to perform an All DTC Scan, the DTC B2B05-92 will be returned.

A software issue in the Telematics unit causing the error to occur. Under certain conditions, if the Power Mode is set to Off while a software update is preparing for installation, the DTC and Code can appear.

Restart the OTA System, then update the Telematics unit to the latest software version. If the software is up to date, and the DTC returns, follow the trouble shooting steps for DTC B2B05-92.

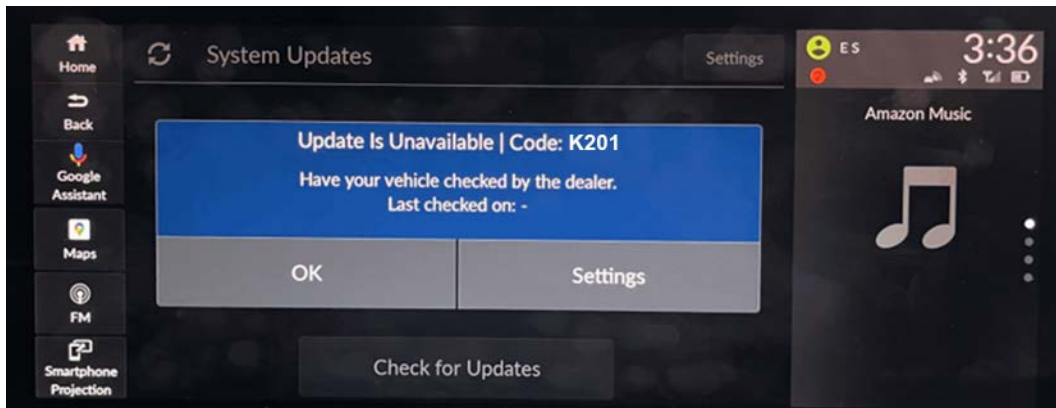
In Hybrid trims, the audio unit may also display Code K201.
