**HYUNDAI**
Technical Service Bulletin

GROUP CAMPAIGN	NUMBER 23-01-042H
DATE APRIL 2023	MODEL(S) PALISADE (LX2) SANTA FE PLUG-IN HYBRID (TM PHEV)

SUBJECT: ENGINE MOUNTING SUPPORT BRACKET RETIGHTENING
(CAMPAIGN TAG)

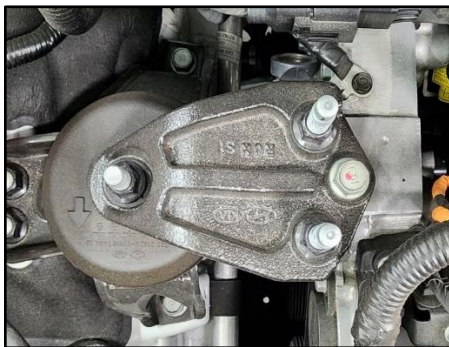
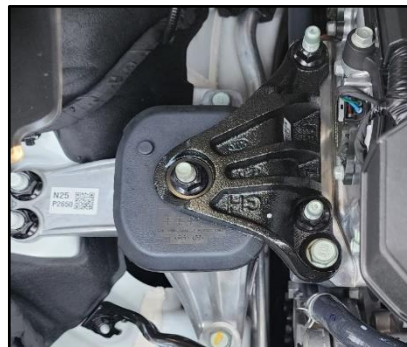
Description: Certain Palisade (LX2) and Santa Fe Plug-In Hybrid (TM PHEV) vehicles may have been produced with engine mounting support bracket fasteners that were not tightened to torque specification. Follow the procedure outlined in this bulletin to retighten the indicated fasteners to the correct specified torque values.
