GROUP	NUMBER
CAMPAIGN	23-01-045H
DATE	MODEL(S)
MAY 2023	PALISADE (LX2)

WATER OUTLET HOSE CLAMP INSPECTION/REPLACEMENT (CAMPAIGN TAC)

Description: Certain 2023MY Palisade (LX2) vehicles may have been produced with the incorrect size water outlet hose clamp during assembly. This can result in a coolant leak during engine operation. Follow the procedure outlined in this TSB to inspect and, if necessary, replace the water outlet hose clamp with the correctly sized hose clamp as listed in the parts catalog.

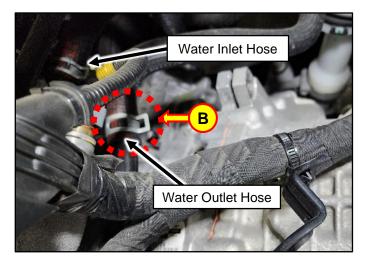
2. Check the number on the water outlet hose clamp (B) in the light.

- If the clamp size number is "22", replacement is not necessary. Inspection is complete.
- If the clamp size number is "24", proceed to the next section to replace the water outlet hose clamp.
