Technical Service Bulletin

GROUP AUTOMATIC TRANSMISSION	NUMBER 23-AT-002H
DATE MAY, 2023	MODEL(S) VELOSTER N (JSN) SANTA FE (TMA) SONATA (DN8a) SANTA CRUZ (NXT) KONA N (OSN) ELANTRA N (CN7N)

SUBJECT: 8-SPEED WET DCT PREVENTION OF MOISTURE INTRUSION INTO HF EOP CONNECTOR

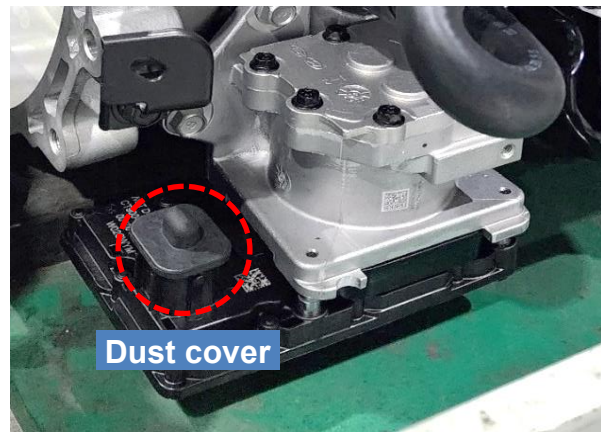
Description: This bulletin provides service procedures to prevent possible moisture intrusion of the HP EOP (High Flow Electric Oil Pump) connector when servicing the 8-speed wet dual clutch transmission (8WDCT). If moisture enters the HF EOP connector, this can result in corrosion and insufficient connection of the terminals.

1. Make sure to use the dust cover on the HF EOP connector when servicing the DCT. Reuse the dust cover if replacing the DCT (for both new and remanufactured).

- If the dust cover is unavailable, use vinyl or an alternative cover.
