Technical Service Bulletin

Subject: LIGHT RESISTANCE AND/OR UNUSUAL NOISE WHEN TURNING STEERING WHEEL LEFT OR RIGHT	Bulletin No.: 06-002/23
	Last Issued : 05/03/2023

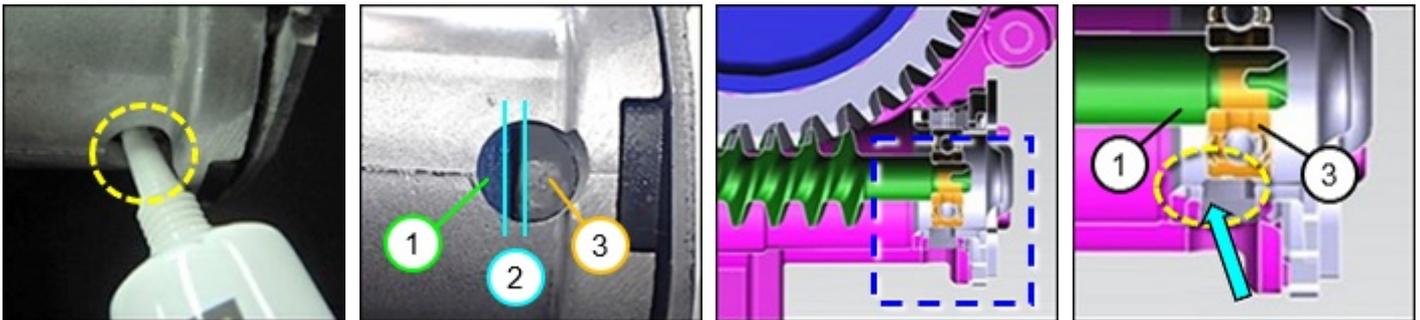
Some vehicles may exhibit a light resistance and/or an unusual noise when turning the steering wheel in either direction. This concern may be caused by **insufficient lubrication between the worm wheel gear and worm shaft.**

- Keep the proper angle of the grease tube to the hole.
- Inject the grease by inserting the tip of the grease tube into the gap (2) between the worm shaft (1) and the bearing (3).
- If the grease overflows from the hole, the grease is not entering the gap.
- To avoid the grease staying at the hole, keep the tip of the grease tube off the bearing (3) and keep the steering wheel turning.
- If the grease does not reach to entire worm gear, the concern may recur.
