Technical Service Bulletin

| Subject: FRONT DOOR INTERFERES WITH REAR DOOR GARNISH (4-DOOR SEDAN) | Bulletin No.: 09-018/23 |

2019-2021 Mazda3 (Japan built 4-door sedan) with VINs lower than JM1BP*****402503 (produced before August 4, 2021)

2019-2023 Mazda3 (Mexico built 4-door sedan) with VINs lower than 3MZBP*****362059 (produced before Feb. 14, 2023)

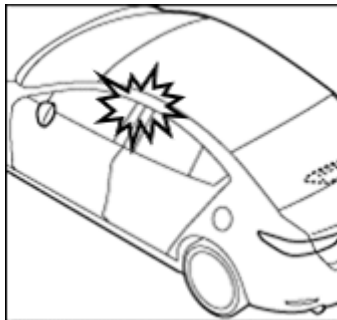
Some vehicles may exhibit the glass run channel of the front door interfering with the rear door garnish.

This is caused by the front door glass run channel not being fixed strongly enough to the door for the following situations where the cycles of door operation may result in interference and lead to damage on the rear door garnish.

- When the front door glass is closed, the glass run channel may be forced to move to the B pillar side.
- During very hot weather, the glass run channel may expand to the B pillar side.

To eliminate this concern, the design of the front door glass run channel has been changed to be fixed stronger to the door.

1. Verify the customer concern.
2. Replace the front door glass run-channels with modified ones, regardless if the other side is damaged or not, following the instructions on MGSS (FRONT DOOR GLASS RUN-CHANNEL REMOVAL/INSTALLATION).
