Subject: REAR DOOR GLASS RUN-CHANNEL DEFORMATION	Bulletin No.: 09-021/23
	Last Issued : 05/09/2023

2019-2023 Mazda3 (Japan built) vehicles with VINs lower than JM1 BP**** ** 606147 (Produced before Nov. 3, 2022)

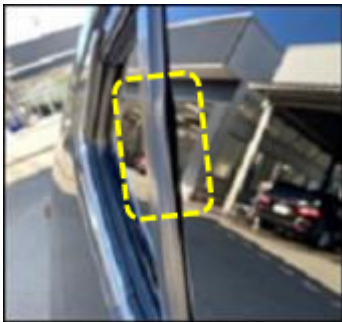
Some vehicles may experience a gap between the glass and the rear door glass run-channel due to run-channel deformation. This causes poor appearance and wind noise when driving at high speed. This concern is due to the incorrect shape of the glass run-channel.

1. Verify the customer concern.
2. Replace the rear door glass run-channel with a modified part according to the instructions on MGSS online (REAR DOOR GLASS RUN-CHANNEL REMOVAL/INSTALLATION)
