Technical Service Bulletin

Subject: SQUEAKING OR RUBBING NOISE WHEN OPENING/CLOSING FRONT DOOR	Bulletin No.: 09-022/23
	Last Issued : 05/16/2023

2024 CX-90

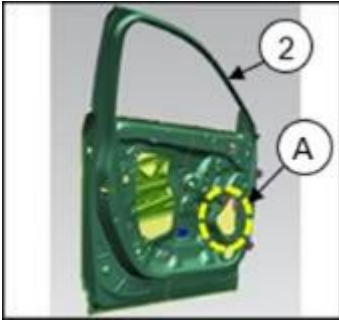
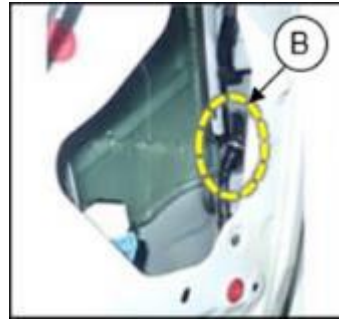
DETAIL OF A

- Opening the front door glass (2) could facilitate the procedure. However, it can be also kept closed during the repair.
- The following image is the left side door with the window opened.
- If the fabric-applying area is wet, wipe it off before applying the fabric.

4. Apply the non-woven fabric(s)(1) to the front door(s)(2) according to the following images.

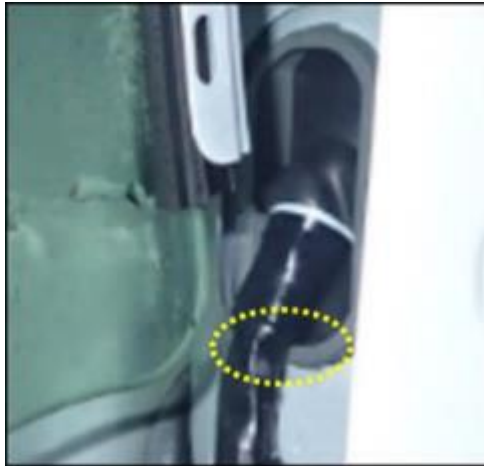
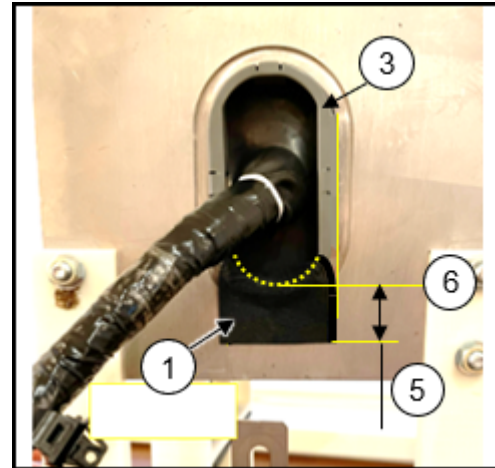
DETAIL OF B

The harness interferes with the bottom edge of the door harness grommet.

Details for applying the non-woven fabric

- The right edge of the non-woven fabric must be aligned with the door harness grommet (3).
- Fold the remaining non-woven fabric over the other side of the hole.

(5) 15 mm (0.6 inches) from the underside of the hole (6) of the door harness grommet (3)
