Service Alert

MAZDA CONNECT SYMPTOM TROUBLESHOOTING (7TH GENERATION VEHICLES)

Service Alert No.: SA-005/23

Last Issued: 05/31/2023

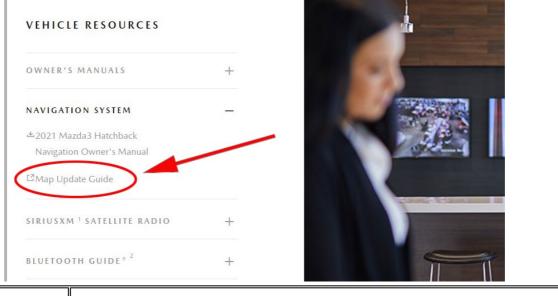
No. 12 How to update the Navigation SD Card Map

License Error message in Mazda Toolbox

Customer is locked out of map update on Mazda Toolbox due to unauthorized or counterfeit navigation SD card.

How to unlock the customer account in Mazda Toolbox

- 1. Purchase a Genuine Mazda Navigation SD card.
- 2. Install new Genuine Mazda Navigation SD card.
