# Service Alert

<b>Subject:</b>  <b>CONNECTED VEHICLE SYMPTOM TROUBLESHOOTING</b>	<b>Service Alert No.:</b> SA-009/23
	<b>Last Issued :</b> 05/24/2023

2019-2023 Mazda3  
2020-2023 CX-30  
2021-2023 CX-5  
2021-2023 CX-9  
2022-2023 MX-30  
2023 CX-50  
2024 CX-90

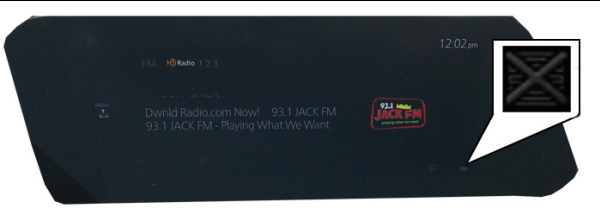
<p>Infotainment Center Display</p>	<ul style="list-style-type: none"> <li>• <b>TCU in Deactivation Mode</b></li> <li>• <b>One Time Passcode (OTP) is processing</b></li> </ul>	<p><b>Reception Icon Shows "X"</b></p>

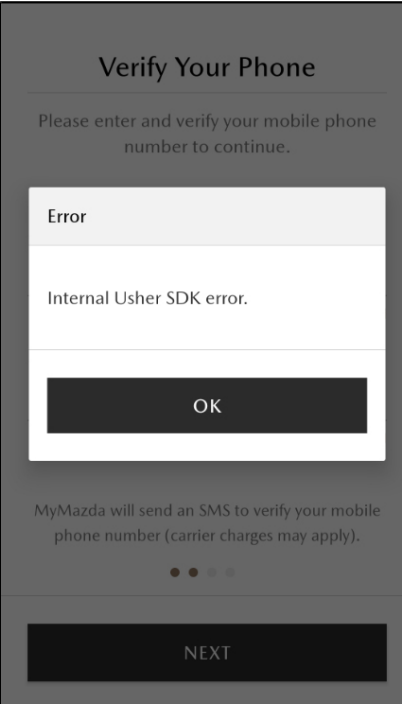
Connected Vehicle Troubleshooting		
Symptom	Cause	Action
<p>The customer is not able to create a MyMazda account. The customer receives the following error:</p> <p><b>MyMazda App</b> - Internal Usher SDK error.</p>

<p><b>MyMazda Website</b> - ERROR! Unable to send one-time password.</p>	<p>Customer inadvertently texted <b>"Stop"</b> to 1-949 518-0058 (Twilio SMS for Mazda)</p>	<p>1. Text <b>"Start"</b> to 1-949 518-0058 (Twilio SMS for Mazda)</p> <p>2. Retry to create a MyMazda account.</p> <p><b>NOTE:</b> USA and Canada only</p>

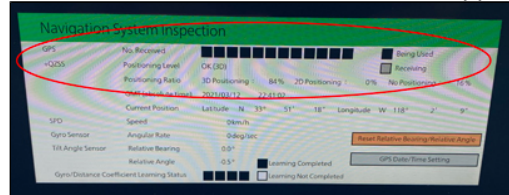
6. Compare Tel antenna No. 1 signal strength with good known vehicle near by. Go to DIAGNOSTIC ASSIST FUNCTION [CONNECTIVITY MASTER UNIT (US)]  
 Functional Inspection / Adjustment -> Navigation System Inspection

**Good** - Contact Hotline for technical support

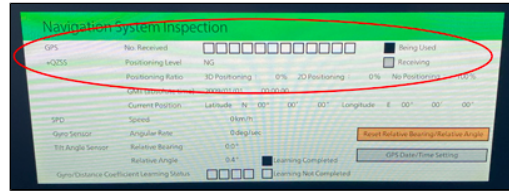
**No Good** - Swap Tel antenna No. 1 with known good vehicle
