<b>Subject:</b> <b>ELECTRICAL CONCERN AND/OR MULTIPLE DTC'S DUE TO AFTERMARKET DEVICE</b>	<b>Service Alert No.: SA-032/23</b>
	<b>Last Issued : 05/24/2023</b>

2007-2023 Mazda3	2007-2015 Mazda5	2013-2023 CX-5	2023 CX-50
2007-2021 Mazda6	2007-2012 CX-7	2016-2023 CX-3	2024 CX-90
2007-2023 MX-5	2007-2023 CX-9	2020-2023 CX-30	
2007-2011 RX-8	2011-2023 Mazda2	2022-2023 MX-30

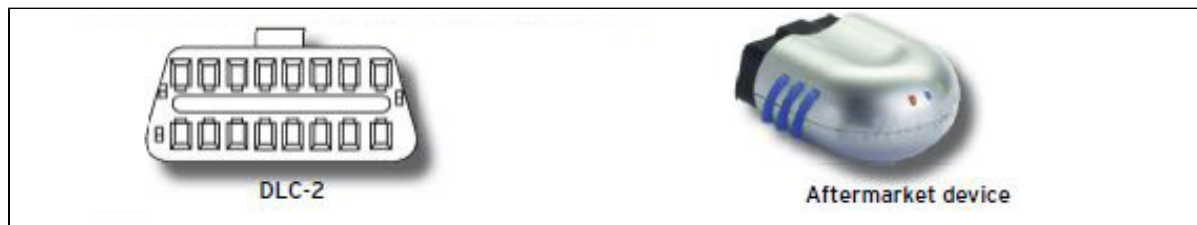
**Example 1**

Some electrical devices connected to the DLC-2 connector by insurance or mobile phone companies may cause:

- Battery discharge. The device may disrupt the CAN system battery saver mode.
- IDS/MMDS will not communicate with the vehicle due to poor DLC-2 connection. The aftermarket device may cause DLC-2 female terminals to spread open.
- DTCs
  - B1041:54 - ADAPTIVE FRONT LIGHTING SYSTEM (AFS) CONTROL MODULE
  - B108E:04 - CENTER DISPLAY INTERNAL MALFUNCTION
  - C0061:54 - DSC HU/CM
  - C1001:92 - FORWARD SENSING CAMERA (FSC)
  - C1001:97 - FORWARD SENSING CAMERA (FSC)
  - U300A:62 - ELECTRIC PARKING BRAKE (EPB)
  - U3004:17 - ACC RELAY CIRCUIT MALFUNCTION
  - U0415:00 - MAZDA RADAR CRUISE CONTROL (MRCC)/SMART BRAKE SUPPORT (SBS)
  - U0420:00 - MAZDA RADAR CRUISE CONTROL (MRCC)/SMART BRAKE SUPPORT (SBS)
  - Multiple DTC's (U0XXX:00 COMMUNICATION ERROR)

- If an aftermarket device is found connected to DLC-2, take a photo and attach it to the RO. Advise the customer to remove it.
- If you determine that no aftermarket devices have been installed, continue with normal MGSS diagnosis.

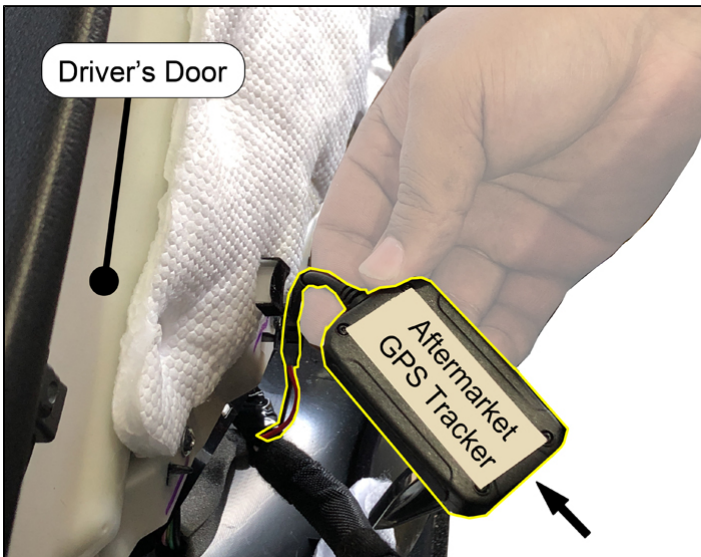
**Example 3**

Some aftermarket devices that are wired to the vehicles’s wiring harness may create unusual electrical symptoms and/or store DTCs.

Below are examples of concerns due to an aftermarket GPS tracking device wired to the power window main switch:

- Engine no start
- Battery discharge
- Main relay buzzing

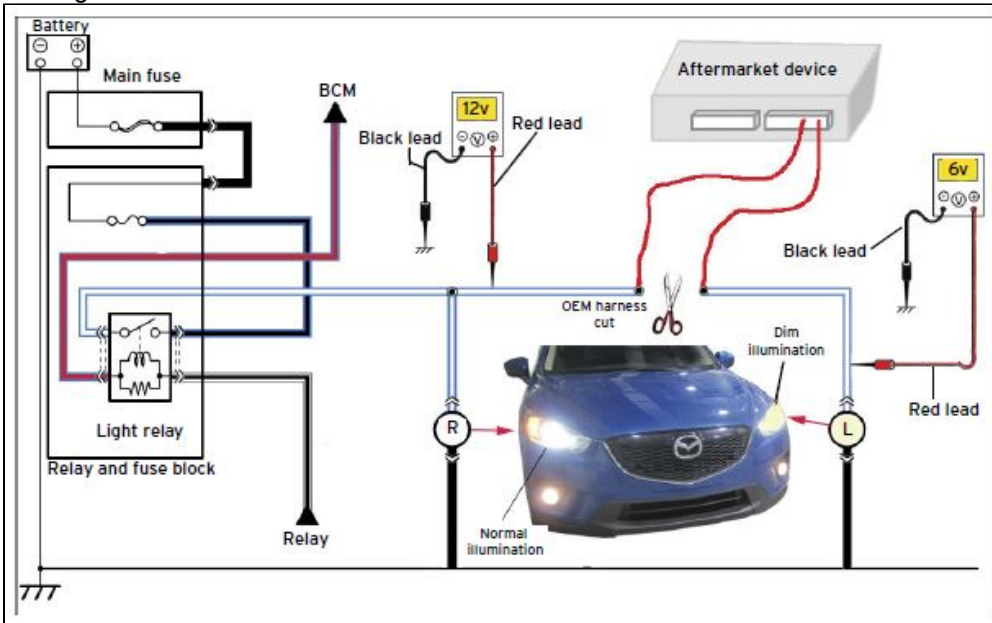
Below is an example of a dim headlight. The aftermarket device changed the headlight circuit resistance, causing a dim headlight.

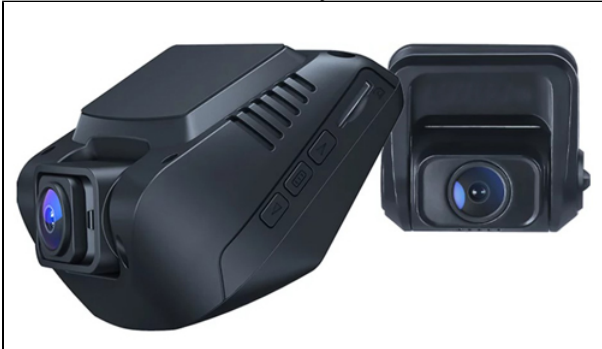
#### Example 4

DTC B119F:01 (TEL antenna No.1 malfunction) stored. This may be caused by an aftermarket dash cam. The aftermarket device may cause electrical noise disturbing the reception of GPS signals.

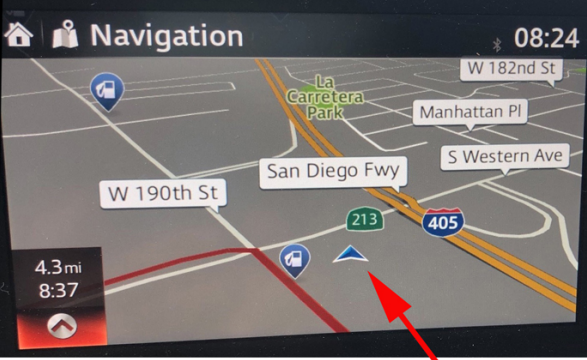
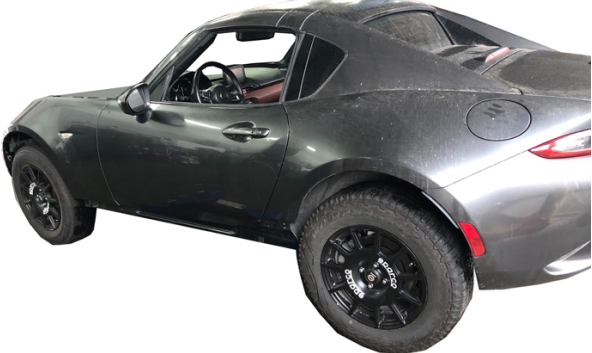
**Example 6**

Navigation display map shows incorrect GPS location (A). This may be caused by over-sized wheels/tires. Confirm correct wheel/tire size according to the tire label.

Navi Map Shows Incorrect GPS position (A)	Possible oversized wheels/tires

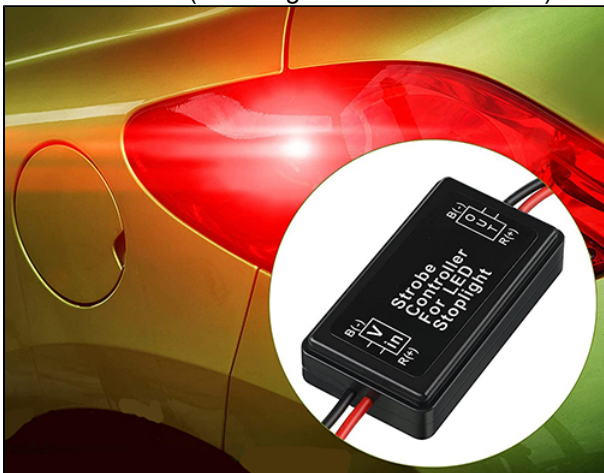
**Example 7**

DTC C0023:14 (Brake light circuit malfunction) stored. This may be caused by an aftermarket brake light flasher.
