#### Subaru Service and Technical Support Line Newsletter

#### April 2023 TechTIPS

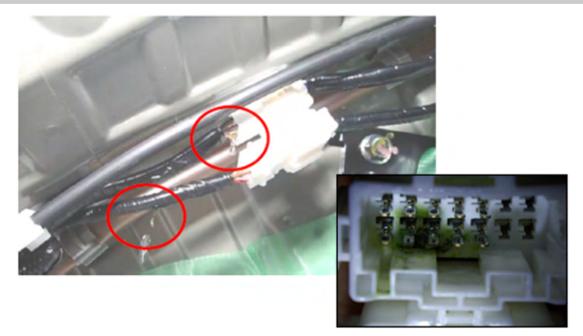
Techline has received reports of issues after installing aftermarket window tint on 2024 Crosstrek and Impreza. There have been reports of the brake lights staying on due to water intrusion. This may be due to the water application on the inside of the rear window glass during aftermarket window tint installation. When applying water to the inside of an open tailgate, the water may run down the inside of electrical harnesses. Extreme caution should always be taken when applying water to areas of a vehicle that are not intended to see water. This could cause corrosion inside connectors not equipped with weather pack or mildew and mold build up in areas that can hold or soak up moisture and not properly drain.

Should a '24 Crosstrek/Impreza come in with a concern of brake lights on all the time, inspect for window tint on the rear glass, and water intrusion in connector Db11.

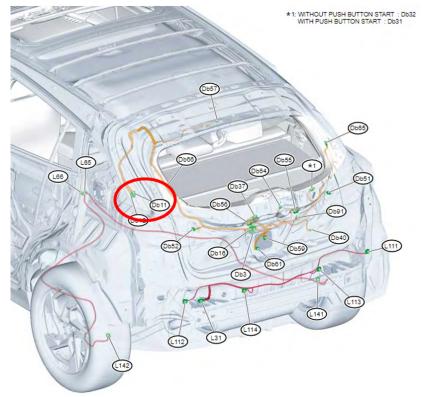
As a reminder a vehicle should always be inspected for anything aftermarket. Aftermarket window tint may not seem like it could cause problems. However, similar water intrusion concerns directly connected to window tint installation have been seen from time to time when the water application is excessive during installation.

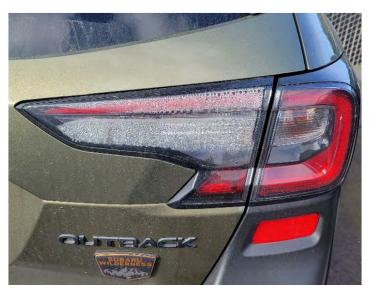
There has been an increase in replacement of exterior lamp assemblies due to condensation build up. This condensation often occurs due to a temperature differential caused by the seasonal temperature and the sun.

It is important to note that this is a normal condition and parts should not be replaced for this concern. It is more common to see this during late fall and early spring. TSB <u>07-59-07R</u> covers this topic and details the cause for this.

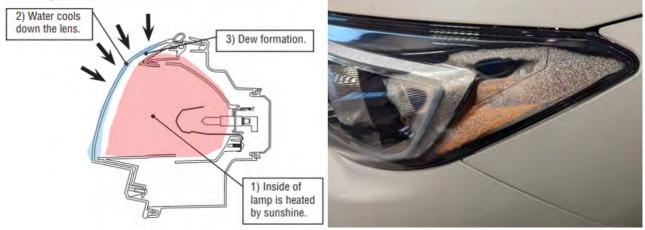
1) If a lamp is unevenly warmed by sunshine as shown in the illustration below, temperature of the area where the sun shines can be about 50° F higher than the other (cold) area. When air circulates inside the lamp, the warm air reacts to the cold surface resulting in formation of condensation.

2) If an already warm lamp lens gets cooled down rapidly (e.g. when water is applied to the lens during vehicle washing), a sudden temperature change can occur resulting in the development of condensation.

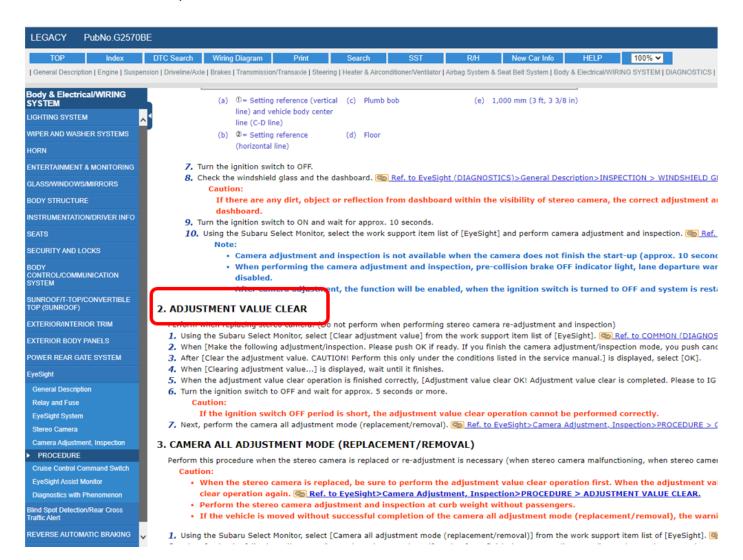
Techline continues to receive calls related to issues after replacing or swapping an Eyesight camera for testing. Any time a module is replaced in a vehicle it is critical to read and perform all the installation directions in STIS for that vehicle. **The programming needed varies depending on year and model.** If the correct installation and programming steps are not followed it is possible that there will be new DTC's after installing a new camera, calibration problems or the Eyesight disabled light illuminating.

For example, a 20MY Outback does not need to have the "Vehicle Information Registration – Parameter Selection" performed:

When comparing the service manual between models, the steps that need to be followed are different. Always refer to STIS for the vehicle being repaired for all installation and programming steps required.
