## Front Bumper/Facia Fit Above Headlamps

Topic number	LI88.20-P-071570
Version	4
Function group	88.20 - Bumpers
Date	5/9/23
Validity	BR290
Reason for change	Adhesive item number changed

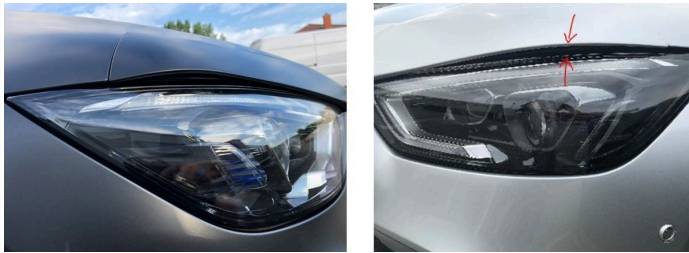
Bulging of front bumper above headlamps (see attachment).

Bulging on bumper above the headlamp

Bonding between bracket and bumper may be separating.

Detach front bumper and check whether the brackets can be easily removed without damaging or deforming the bumper (little to no (remaining) bond) or whether the bond is (still) too strong.
