SERVICE BULLETIN

APPLICABILITY: 2019-23MY Impreza
 2019-23MY Crosstrek (Including Hybrid Model)
 2019-23MY Forester
 2019MY Legacy/ Outback
 2019-21MY WRX
 2019-21MY WRX STI
 2019-21MY BRZ- Navigation -equipped ONLY
 2019-22MY Ascent

NUMBER: 15-236-18R

SUBJECT: Reprogramming File Availability for Optimization of Harman Gen 3.1 and Gen 3.1α Audio and Navigation Head Units

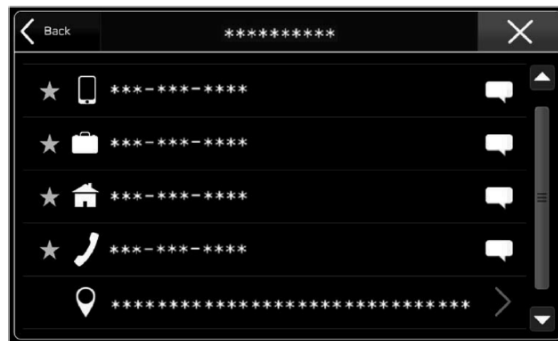
- 1) AM/FM radio station presets are lost.
- 2) Favorite Phone Contacts list is lost.

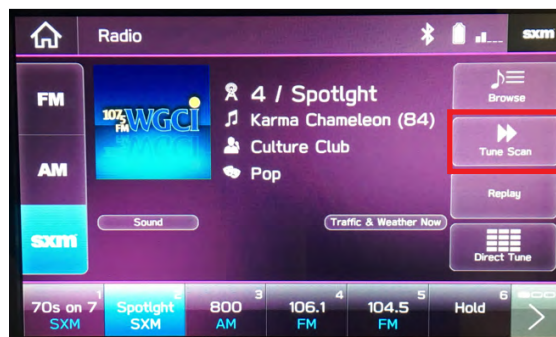
<Scan> previously displayed on SXM screen was changed to <Tune Scan> (a.k.a. SEEK).
