## SERVICE BULLETIN

**APPLICABILITY:** 2020-23MY Legacy & Outback  
 2023MY Ascent

**NUMBER:** 07-213-22R

**SUBJECT:** Genuine Battery Replacement

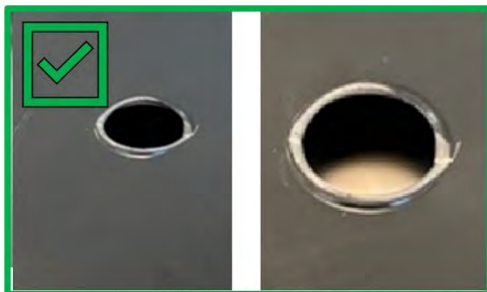
Remaining Height Is Less Than 2mm

**CAUTION:** Be sure the protrusions are trimmed flush. The remaining protrusion height **MUST** be less than 2mm to provide proper fitment.

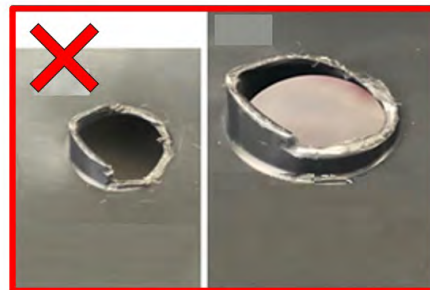
Remaining Height Is More Than 2mm
