**PRODUCT CAMPAIGN BULLETIN**

**APPLICABILITY:** 2023 MY Impreza

**NUMBER:** WRI-23R

**SUBJECT:** Safety Recall/STOP SALE – Stop Lamp Switch Adjustment

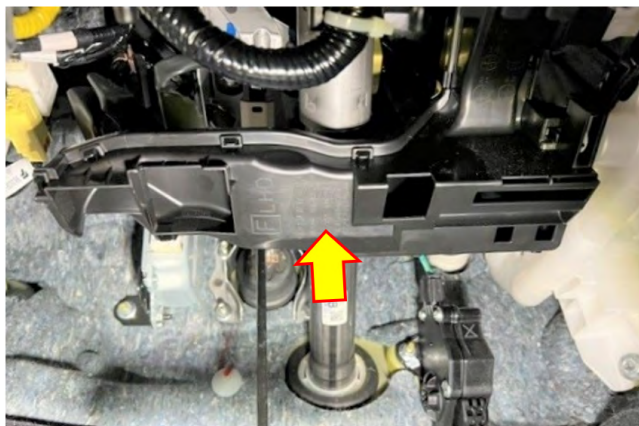
**STEP 1:** Remove the left front footwell air duct.

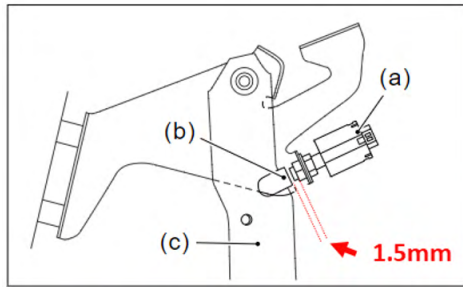
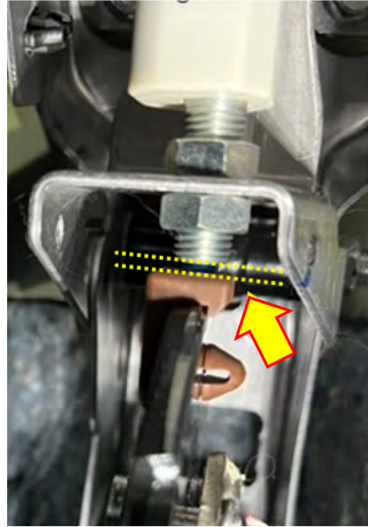
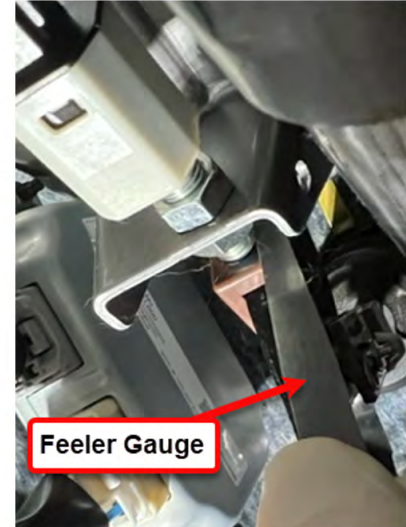
**STEP 2:** Using a feeler gauge, check the switch plunger extension length between the stop lamp switch threads and the stopper section of the brake pedal.

- (a) Stop light switch
- (b) Stopper
- (c) Brake pedal

**The plunger portion of the switch should extend between the stopper section of the brake pedal and the stop lamp switch threads 1.5mm (0.06 in) in length.**

- If the plunger extension length found is the specified value, then no further service procedures are required. Reinstall the left front footwell air duct.
- If the plunger extension length found is not the specified value, an adjustment will be required. Proceed to the adjustment section of this bulletin located on page #4.

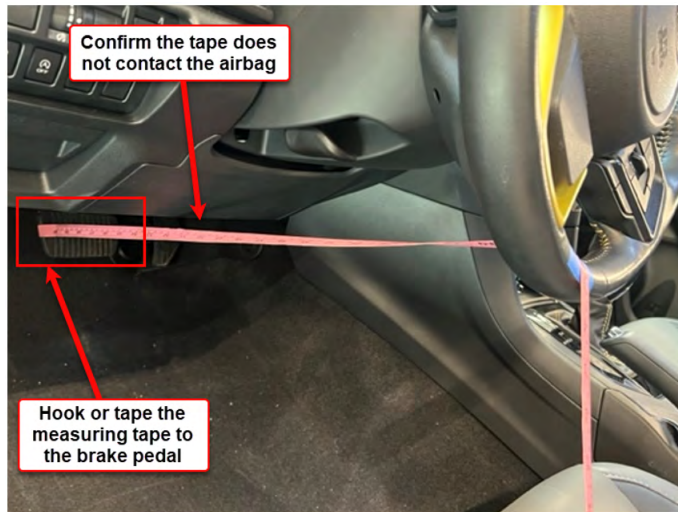
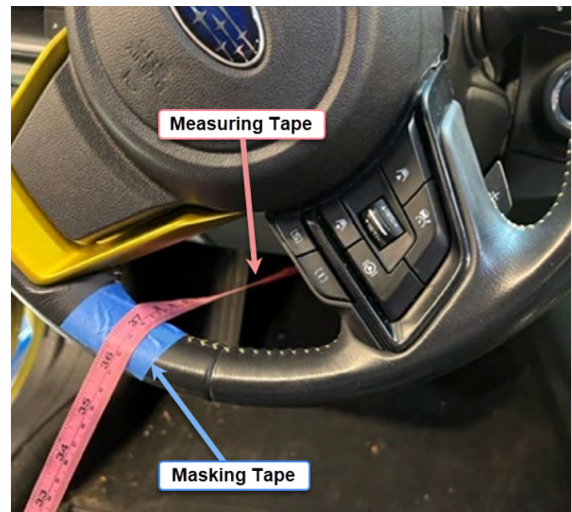
**NOTE:** If needed and to maintain consistency, apply a piece of tape to the brake pedal to be used as a reference mark when making measurements. The end of the measuring tape can also be taped to the pedal itself.

**STEP 3:** Apply non-marking painter's tape to the bottom of the steering wheel to be used for making a reference mark.

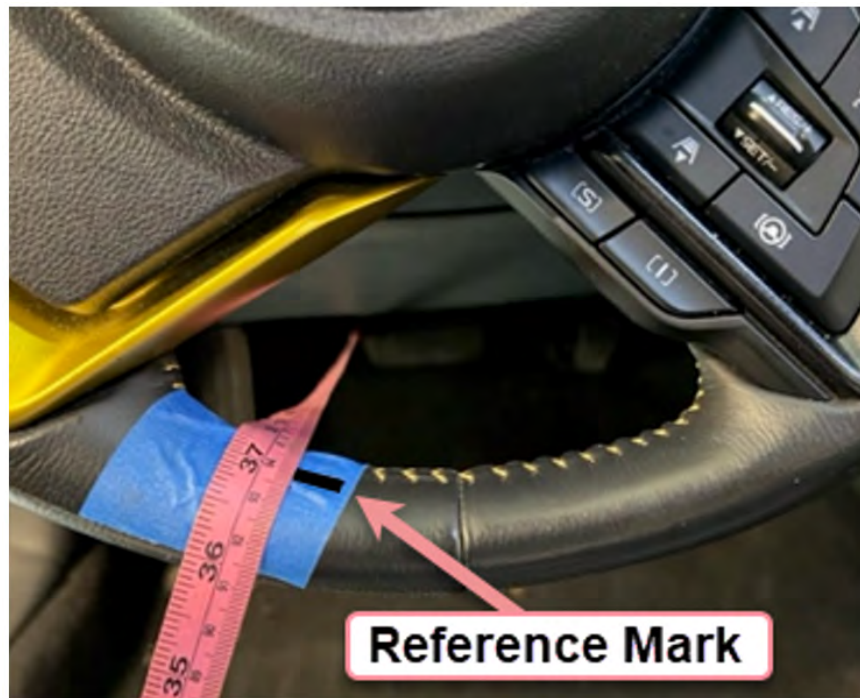
**STEP 4:** Write a reference mark on the taped section of the steering wheel. Make a measurement to the brake pedal in its current position and record it.

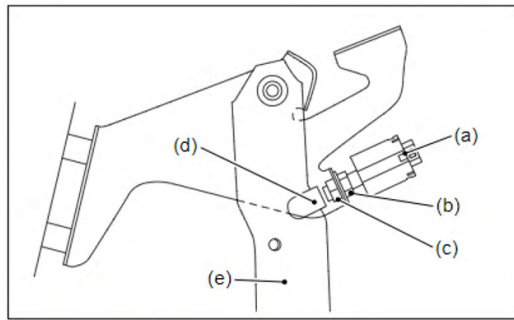
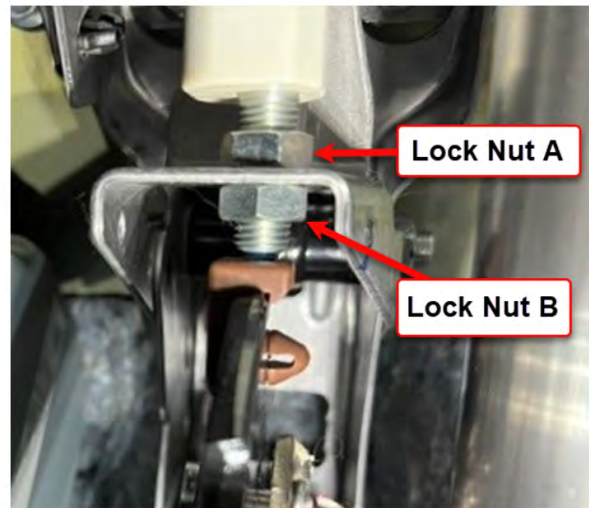
- (a) Stop light switch
- (b) Lock nut A
- (c) Lock nut B
- (d) Stopper
- (e) Brake pedal

**IMPORTANT:** Never adjust the pedal stroke to less than 3mm. Doing so may cause the stop lamp to illuminate without pressing the brake pedal.

**STEP 6:** Loosen lock nut A. Turn lock nut B to adjust the stop lamp switch plunger extension. Turning lock nut B by 90 degrees will adjust the extension length approximately 0.15mm. Once the desired length is achieved, tighten lock nut A to 8nm (0.8 kgf-m, 5.9 ftlbs).
