GLOBAL SAFETY FIELD INVESTIGATIONS
DCS6598
URGENT - DISTRIBUTE IMMEDIATELY

Subject: N222375791-04 - Customer Satisfaction Program
Park Assist Retrofit
Population Update

Models: 2022 – 2023 Buick Enclave
2022 – 2023 Cadillac XT4
2022 – 2023 Cadillac XT5
2022 – 2023 Cadillac XT6
2022 Chevrolet Blazer
2022 – 2023 Chevrolet Camaro
2022 Chevrolet Silverado 1500 LTD
2022 – 2023 Chevrolet Silverado 2500HD/3500HD
2022 - 2023 GMC Acadia
2022 GMC Sierra 1500 Limited
2022 – 2023 GMC Sierra 2500HD/3500HD

N222375791 Park Assist Retrofit

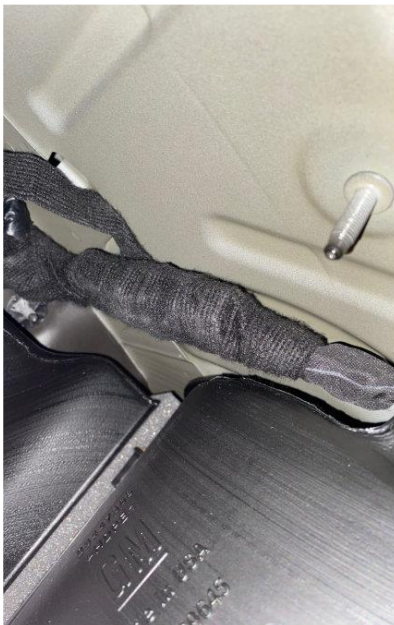
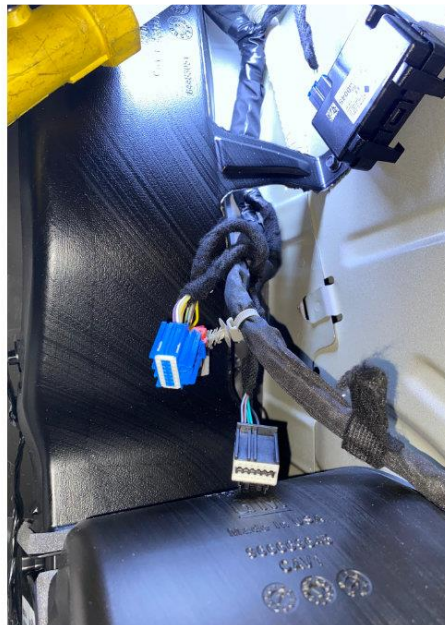
6288463

Note: The wiring harness for the Parking Assist Control Module may be wrapped around an adjacent wiring harness as shown above. Remove the attaching tape by unwrapping. Do NOT cut the tape as it could damage the wiring harness.

1. Install the new Parking Assist Control Module. Refer to *Parking Assist Control Module Replacement* in SI.

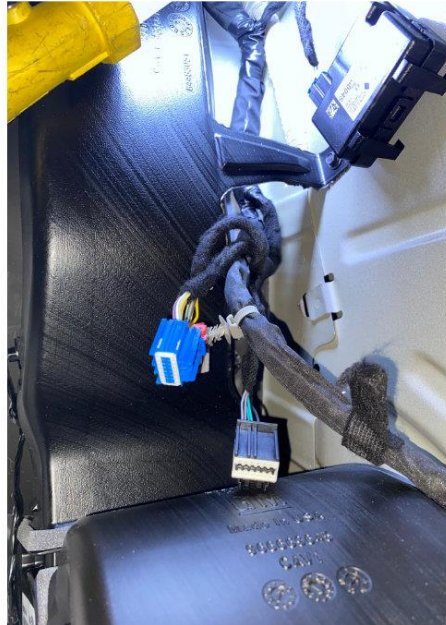
6288463

Note: The wiring harness for the Parking Assist Control Module may be wrapped around an adjacent wiring harness as shown above. Remove the attaching tape by unwrapping. Do NOT cut the tape as it could damage the wiring harness.

1. Install the new Parking Assist Control Module. Refer to *Parking Assist Control Module Replacement* in SI.

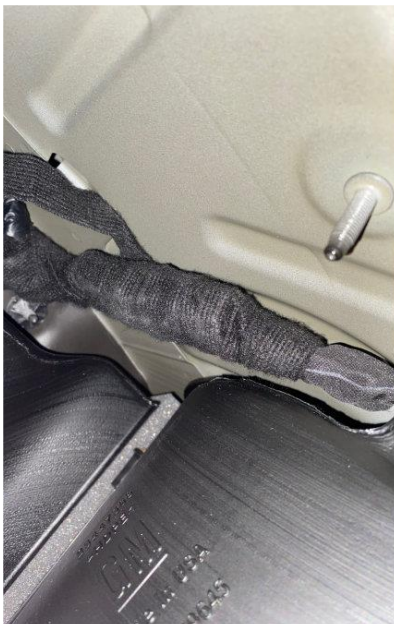
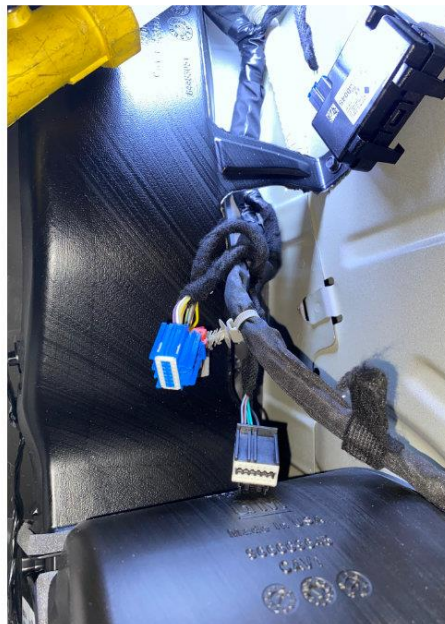
6288463

Note: The wiring harness for the Parking Assist Control Module may be wrapped around an adjacent wiring harness as shown above. Remove the attaching tape by unwrapping. Do NOT cut the tape as it could damage the wiring harness.

1. Install the new Parking Assist Control Module. Refer to *Parking Assist Control Module Replacement* in SI.

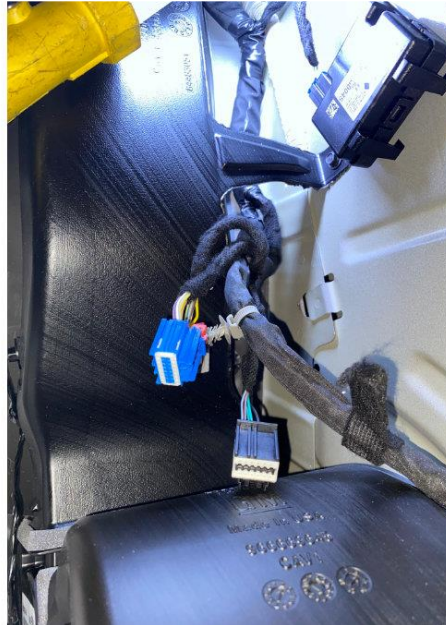
6288463

Note: The wiring harness for the Parking Assist Control Module may be wrapped around an adjacent wiring harness as shown above. Remove the attaching tape by unwrapping. Do NOT cut the tape as it could damage the wiring harness.

1. Install the new Parking Assist Control Module. Refer to *Parking Assist Control Module Replacement* in SI.
