Service Bulletin

Bulletin No.: 23-NA-072

Subject: Shudders or Shakes at Low Speeds

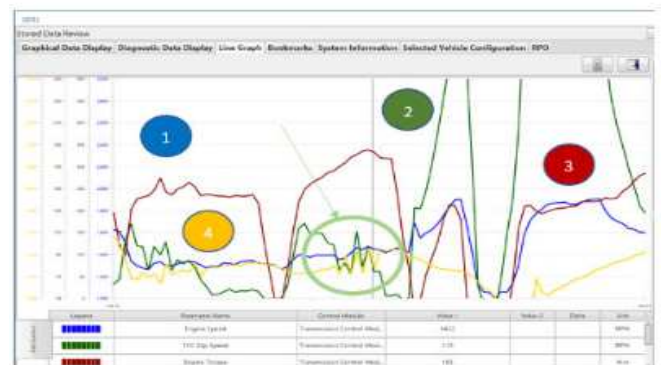
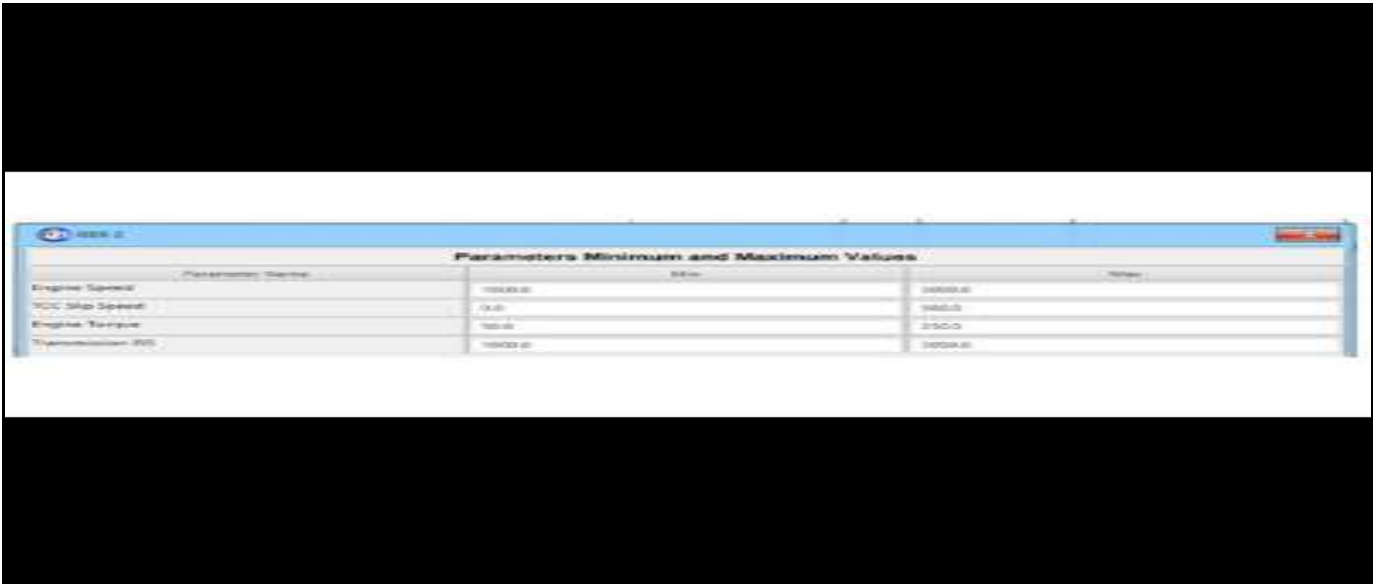
6325119

TCC Shudder: (Typically seen on 4th-5th Upshift as ISS Oscillation)

Record GDS2 Session Log and look for ISS oscillation when driveline disturbance occurs.

Diagnose by performing launch from 0 mph speed at 15-20% pedal up to 30 mph.

Condition present when TCC Slip less than 150 rpm maximum.

1. Engine Speed
2. TCC Slip Speed
3. Engine Torque
4. ISS (Turbine Speed) will show oscillation

TCC Shudder	ISS (Peak-Peak)	Action	Comment
Normal	<50 rpm	Do Nothing	Not a Torque Converter/ATF Issue
Degraded	>50 rpm <200 rpm	Proceed with ATF Drain and Refill	ATF Degradation has occurred. Check Fluid Condition (Instructions below "Fluid Condition Check")
Damaged	>200 rpm	Replace Torque Converter	Hardware damage has likely occurred.

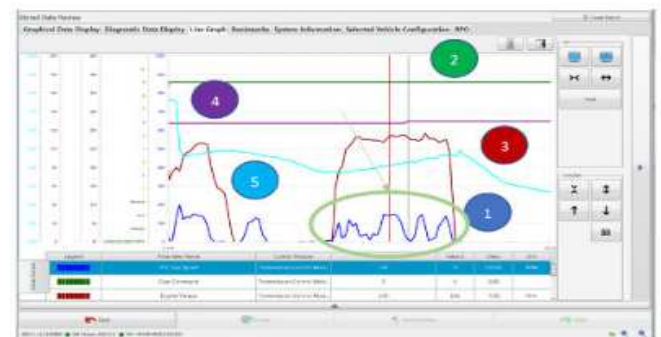
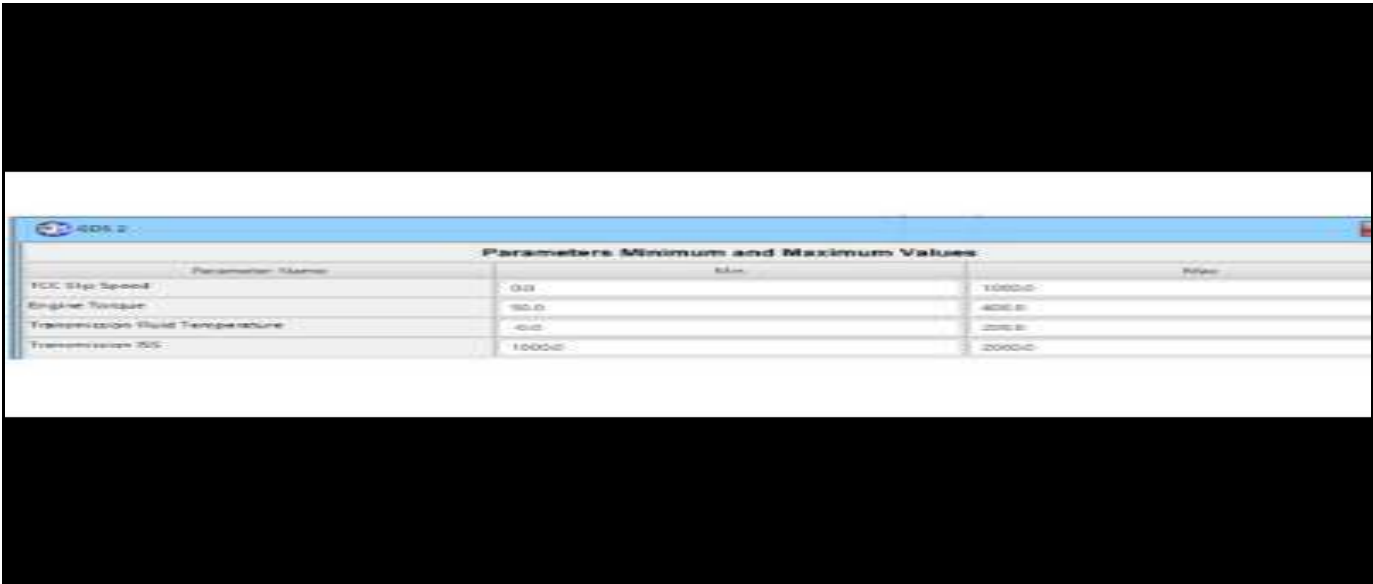
6325122

Poor TCC Control: (Typically seen in higher gear 8th-9th) Steady-State Torque (50-70kph)

1. TCC Slip
2. Gear
3. Engine Torque
4. ATF Temp
5. ISS

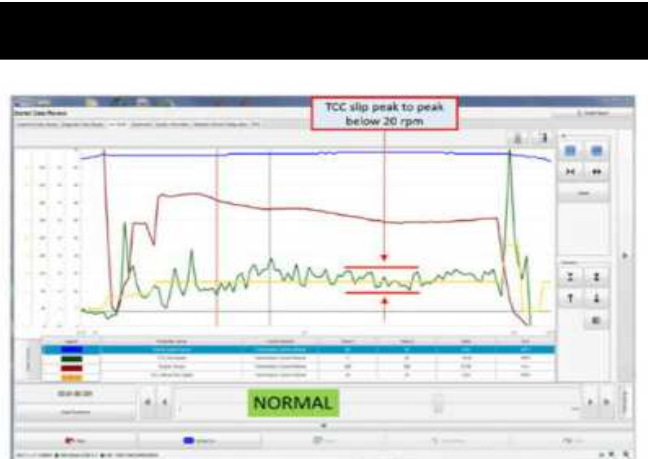
Figure 2 Parameter Normal Test Result

TCC SLIP CONTROL TEST RESULT	TCC RPM Slip Peak to Peak, at Steady Throttle	ACTION
Figure 2 Normal	Below 20 RPM	Do nothing
Figure 3 Degraded	Near 60 RPM - repeating	ATF Degradation has occurred. Check Fluid Condition (Instructions below "Fluid Condition Check")
Figure 4 Damaged	Near 100 RPM-erratic	Hardware damage has likely occurred. Replace Torque Converter

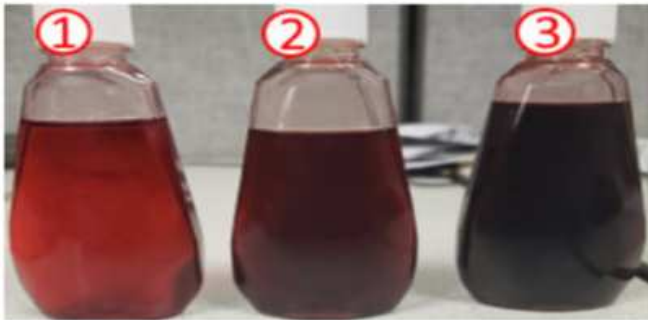
6325134

- The fluid should be red or brown.
- The fluid should be transparent so that objects or writing can be seen through it. Sample #1 is an example of acceptable fluid. Sample #2 is an example of very dark fluid. Sample #3 is an example of black fluid. Samples 1, 2, or 3 would be acceptable to perform the fluid drain and fill if sample does not also have one of the following three conditions.

- In addition to checking the fluid color and transparency, the fluid should be checked for an odor of burnt fluid. If the fluid is very dark (Sample #2), black (Sample #3), and has a burnt odor it would indicate clutch damage has occurred internally in the transmission and it would need to be removed from the vehicle and investigated.

- Fluid that is cloudy or milky or appears to be contaminated with water indicates engine coolant or water contamination. Refer to the latest version of Service Bulletin 08-07-30-035 for testing and, if confirmed, find the source of the coolant/water and repair. Then follow service manual instructions “engine coolant/water in transmission” to repair the transmission.

- Inspect the fluid for excessive metal particles or other debris:
 - A small amount of “friction” material is a “normal” condition.
 - A small amount of “metal” from the manufacturing process is a “normal” condition. This is observed as fine silver streaks floating in the fluid.
 - If large pieces and/or metal pieces are noted in the fluid, or the fluid when rubbed between fingers feels gritty/sandy, it would indicate hardware damage has occurred internally in the transmission and it would need to be removed from the vehicle and investigated.

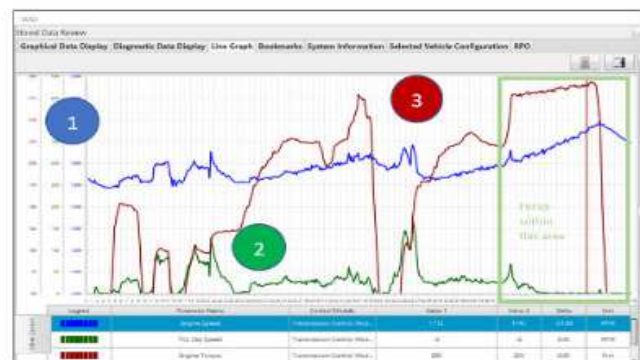
6325131

High Torque Locked Condition — If complaint exists at engine torques >287 Nm, where the measured TCC Slip is ~0 rpm, then this is operating as designed. In order to protect the clutch, we must lock it up at these higher engine torques. Commanding TCC Locked should provide same performance as this condition.

1. Engine Speed
2. TCC Slip
3. Engine Torque
