# Service Bulletin

Bulletin No.: 23-NA-095

**Subject: Lane Keep Assist Unavailable / Adaptive Cruise Control Inop / Service Driver Assist Systems / Amber Front Collision Icon On / Dead Battery / No Crank / Front View Camera / Auto Start Stop Inop / Unable To Complete Camera Learn Stops At 94% /DTC U3000 44 49 54 and/or 57**

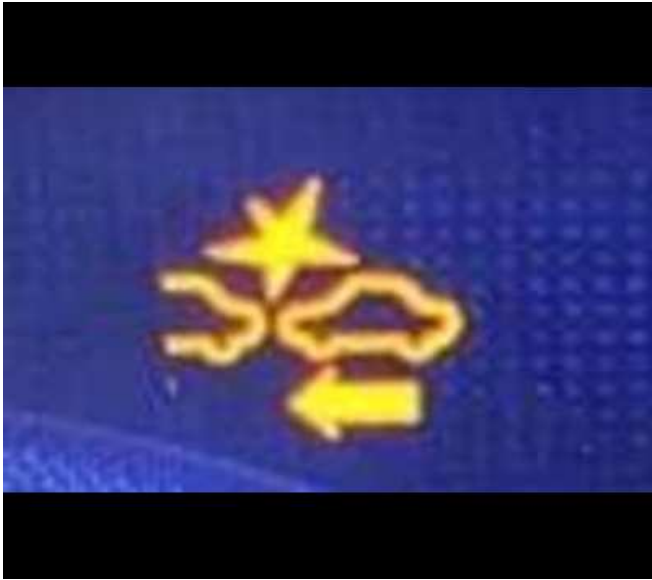
6054884

<b>Involved Region or Country</b>	North America, Europe, Middle East, Bolivia, Chile, Colombia, Ecuador, Paraguay, Peru, Uruguay, GM Korea Company, Thailand, Other Africa
<b>Additional Options (RPOs)</b>	Equipped with RPO UHY and without RPO UGN
<b>Condition</b>	<p>Some customers may comment on an amber Forward Collision icon displayed in the IPC, as shown below. Also, DTC U3000 symptom 44, 49, 54, and/or 57 may or may not be set current in the Front View Camera Module. In some cases, there could be a low or dead battery condition. Customers may also notice certain features related to the Front View Camera are unavailable, such as:</p> <ul style="list-style-type: none"> <li>– Forward Collision Alert (RPO: UEU)</li> <li>– Following Distance Indicator (RPO: UE4)</li> <li>– Low Speed Collision Mitigation Braking (RPO: UHY)</li> <li>– Pedestrian Collision Mitigation Braking (RPO: UKJ)</li> <li>– Lane Keep Assist (RPO: UHX)</li> <li>– Automatic High Beam Assist (RPO: TQ5)</li> <li>– Adaptive Cruise Control (RPO: KSG)</li> </ul> <p><b>Note:</b> Because this condition could cause a low/dead battery, it can cause the Auto Stop/Start feature to be disabled due to the battery start of charge. The front view camera module issue should be corrected first before diagnosing an auto stop/start concern.</p>

<b>Cause</b>	The cause of the condition may be Onstar performing a task, which causes the B174W Front View Camera to set the DTC and disable during the next vehicle start up.
<b>Correction</b>	Refer to the Service Procedure below.

1. Turn the ignition off.
2. Reprogram the Front Camera Module with the latest software in SPS. Refer to *Front View Camera Module Programming and Setup* in SI.

3. Clear any DTCs.
4. Check camera operation.
  - If the camera operation has returned, then no further action is required.
  - If the camera operation has NOT returned, then perform a camera relearn using GDS2.
  - If the camera will not complete the Front View Camera relearn procedure, then see Extended Camera Relearn Procedure shown below.
