Technical Service Bulletin

40 Front shock absorber cap, cracking noises/spring jumps when steering or when maneuvering

40 23 57 2047758/9 May 24, 2023. Supersedes Technical Service Bulletin Group 40 number 22-46 dated July 29, 2022, for reasons listed below.

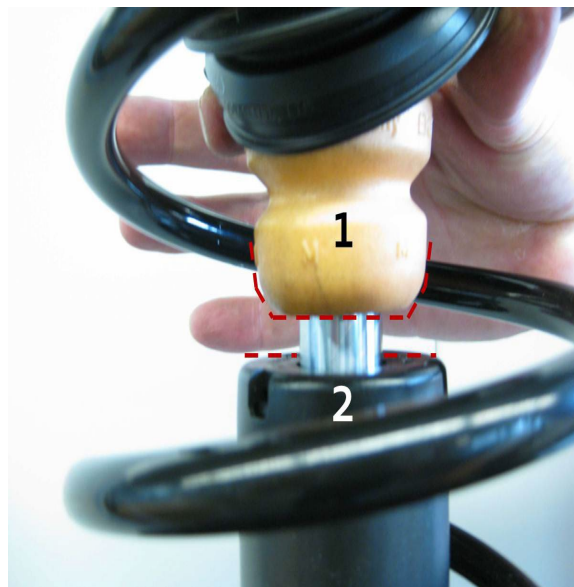
Figure 1. Shock absorber and buffer stop.

The buffer stop for the shock absorber (Figure 1, 1) can cause noises if it touches the front shock absorber cap (Figure 1, 2).

Lightly lubricate the contact surface (red dotted line) between buffer stop for shock absorber (Figure 1, 1) and front shock absorber cap (Figure 1, 2) with 5 grams grease G 000 405 A2 per side.

Tip: Check the protective sleeve of the front shock absorber for correct fit, they should turn easily in the axial deep-groove ball bearing/sleeve bearing.
