Technical Service Bulletin

68 Noises from the dash panel around the MMI display

68 23 43 2056298/6 May 30, 2023. Supersedes Technical Service Bulletin Group 68 number 23-42 dated May 19, 2023, for reasons listed below.

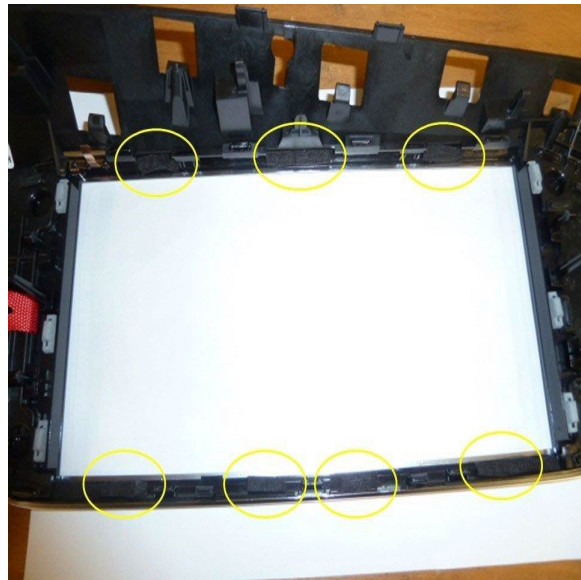
The dash panel trim can cause noise at the contact points.

Figure 1. Apply felt strips to the circled areas.

- Felt strips 533867910A.
1. Remove the trim strip of the dash panel and stick the felt adhesive tape on the areas marked with yellow circles (Figure 1).

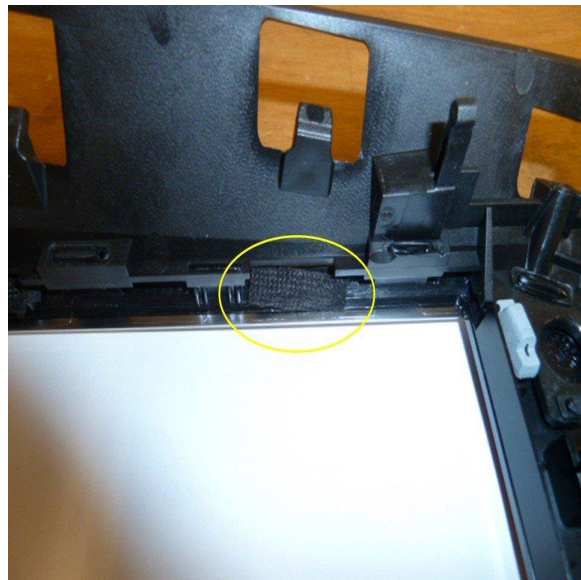
Figure 2. Close-up of Figure 1.

2. The felt strips shown in Figure 1 and 2 must be stuck on and folded back behind the clip (Figures 3 - 4).

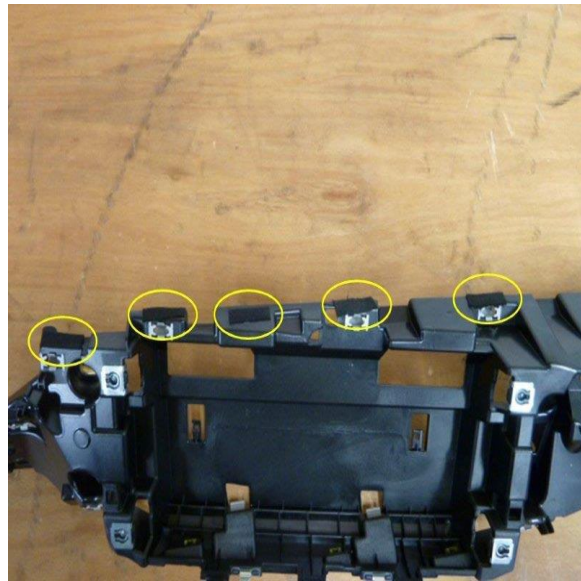
Figure 3. Apply felt strips to the circled areas.

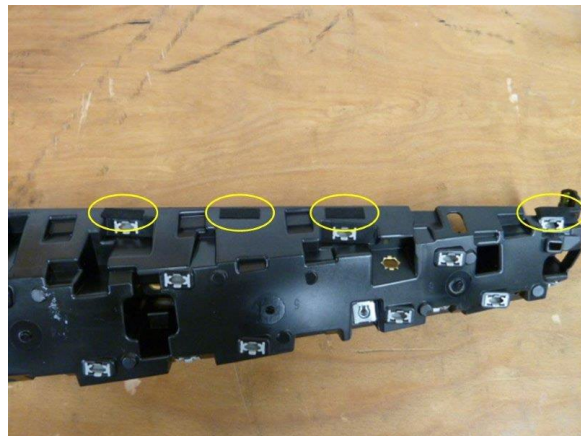
Figure 4. Apply felt strips to the circled areas.
