# Service Bulletin

Bulletin No.: 23-NA-097

**Subject: Upper Glove Box Door does not Open when Button is Depressed or Takes Multiple Presses to Open**

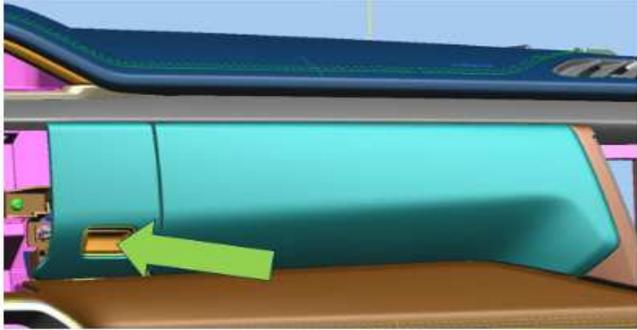
<b>Involved Region or Country</b>	North America, Middle East, Israel
<b>Condition</b>	Some customers may comment that it takes multiple tries to open the upper glove box and/or the customer must hit the upper glove box door or push the button several times for the mechanism to engage.
<b>Cause</b>	<div style="text-align: center;">

</div> <p style="text-align: right; font-size: small;">6361432</p> <p>The cause of the condition may be that the latch pawl is too long and not releasing the door, causing the door to remain closed.</p>
<b>Correction</b>	If the door will not open, you will need to file/sand down the latch pawl following the Service Procedure outlined below.
