27/23 ENU

Power Transmission Symptom – 7th Gear cannot be engaged: Checking Locking Piece (SY 27/23)

Model Line: 911 (992)

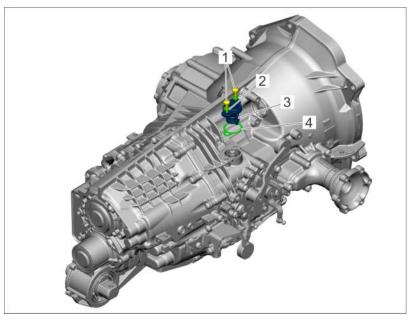
Cause: The locking piece may be jammed by metal particles.

Work Procedure: 1 Remove locking piece \Rightarrow Locking piece -3-.

⇒ Workshop Manual '353019 Removing and installing locking piece'
