**Mixer ladder bolts may have been over-torqued resulting in the need for new hardware**

**Date:** April 13, 2023  
**Bulletin Name:** MXR-TSB-032  
**Model:** Bridgemaster Mixer (93) and Standard Mixer (90)  
**Model Year:** 2022

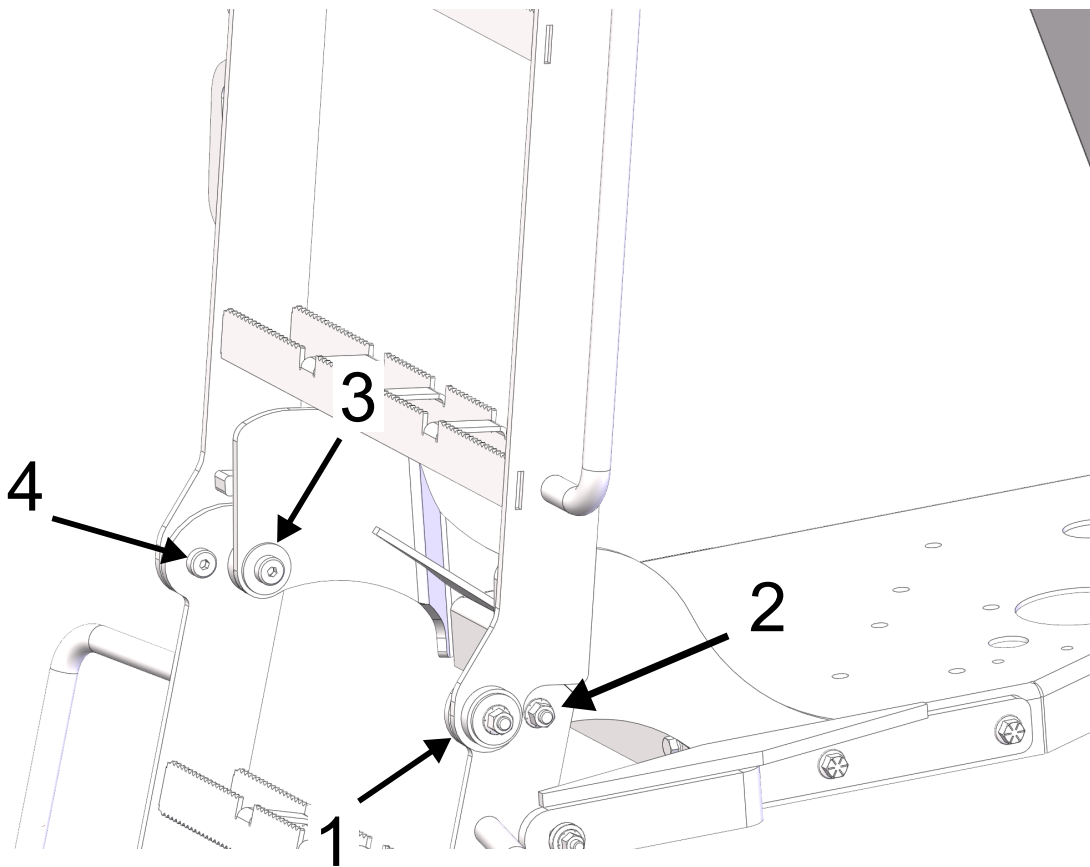
Figure 1

McNeilus Truck and Manufacturing identified an issue with over-torqued bolts on the lower ladder platform. The bolts used to secure the lower ladders to the lower ladder platform were over-torqued causing the bolts to fail. New hardware needs to be installed in place of the over-torqued bolts.

2. Unfold the lower ladder to the down position.
3. Use a wrench to remove the existing bolts, washers, and nuts that secure the assembly at Item 1 in Figure 1. Discard the existing hardware.

4. Use a bolt, nut, and washer to secure the assembly joint at Item 1 in Figure 1. Use a torque wrench to torque the nut to 33 ft.-lbs.
5. Once torqued to 33 ft.-lbs., back the nut off by 1/2 turn.

6. Repeat steps 3 - 5 for the fasteners securing the assembly at Items 2, 3, and 4.
7. The procedure is complete. Remove your company's Lockout/Tagout procedure. If your company does not have a Lockout/Tagout procedure, follow OSHA 1910.147 and 1910.146 Confined Space as appropriate. Chock wheels and engage the service brake. Return the truck to service.
