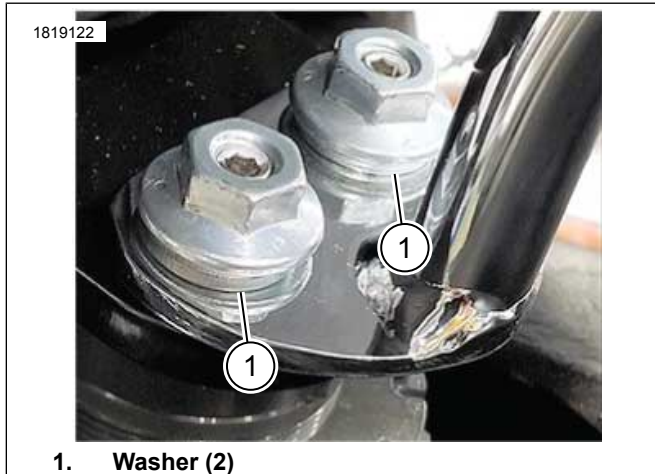
Figure 2. Incorrect-Extra Washer

- Extra Washers:** If found, remove flange nuts and discard washers. Install Flange Nut (Part No. 7499) and tighten. See Figure 2.

Torque: 5–7 ft-lbs (6.8–9.5 N·m) *Flange Nut*

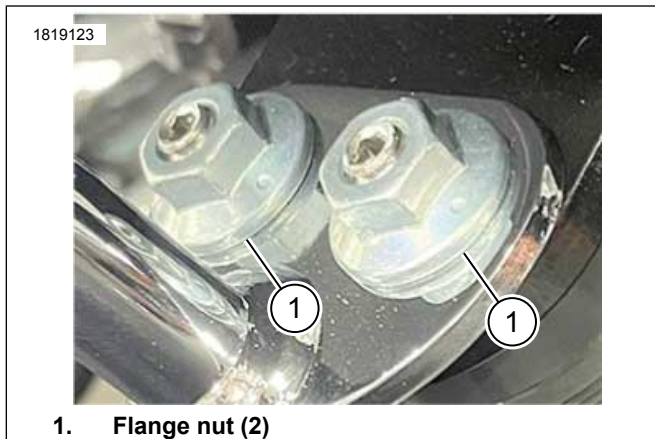
- Flange Nuts:** Confirmed, work complete. See Figure 3.

Figure 3. Correct-Flange Nut Only
