**718 GTS 4.0 - Brake Booster (Power Brake) Warning in Instrument Cluster**

**Vehicles Affected**

Models	Model Year	Model Type	VIN Range	Vehicle-Specific Equipment
718	2021 - 2023	982160 982360 982370	n/a	n/a

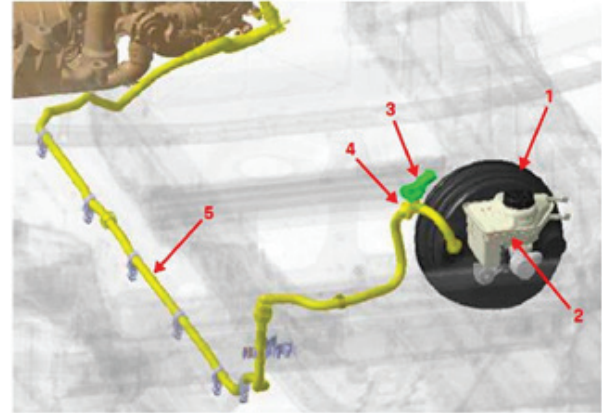
Figure 1

The value of the vacuum line pressure sensor (3) upstream of the brake booster is stored immediately after "wake up." The value is recorded again after 1.5 seconds. Fault P055600 sets if the difference between the two values does not meet or exceed the threshold defined by the DME.

Although this fault is possible at any altitude, it is more likely to occur at higher altitudes due to the lower ambient pressure.
