Technical Service Bulletin

SUBJECT:		No:	TSB-23-42A-002
ICE BUILD UP IN A-PILLAR AREA CAUSING INABILITY TO OPEN FRONT DOOR(S)		DATE:	May 2023
		MODEL:	2022-2023 Outlander and Outlander Plug- in Hybrid
CIRCULATE TO:	<input type="checkbox"/> GENERAL MANAGER	<input checked="" type="checkbox"/> PARTS MANAGER	<input checked="" type="checkbox"/> TECHNICIAN
<input checked="" type="checkbox"/> SERVICE ADVISOR	<input checked="" type="checkbox"/> SERVICE MANAGER	<input checked="" type="checkbox"/> WARRANTY PROCESSOR	<input type="checkbox"/> SALES MANAGER

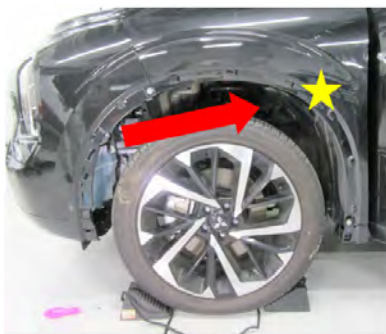
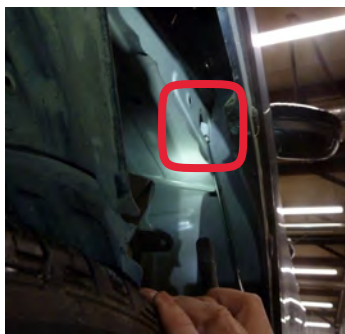
Customers may complain that they are unable to open the front door(s) of the vehicle. Rain, snow and sleet may enter the A-Pillar area (between the front fender and door) where the windshield glass and A-Pillar garnish meet, accumulate and freeze, causing the concern.

1. Remove the front fillet molding and wheelhouse splash shield. Looking in the direction of the arrow (see image below), the area for the padding to be adhered to can be seen (behind the star).
