POWERTRAIN – STARTUP BATTERY REDUCED STATE OF CHARGE

23MY – MHEV Defender, Discovery, Range Rover, RR Sport, RR Velar, Jaguar F-PACE

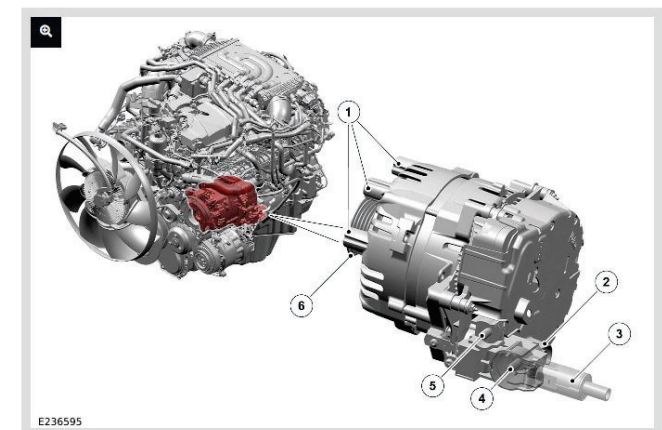
BELT INTEGRATED STARTER GENERATOR

- Customers are reporting 'Stop Safely' and 'Electric Charging fault' warning messages displayed on the Instrument Panel Cluster.

- The following Diagnostic Trouble Codes (DTC)s may also be stored in the Battery Energy Control Module (BECM):
 - - U0120-00
 - - P0DA8-62
 - - U0064-87..

- Please raise a TA and collect the PMZ logs with original parts if fault can be reproduced, add to TA. Then renew the BISG, if TA recommended.
- If the fault persists after BISG replacement: Collect logs again with new part, open and share it on TA referencing the SSM and Engineering : PTS_100 for further guidance.
