POWERTRAIN – P6 ENGINE, INCLUDING PHEV – ROUGH IDLE, MIL ON

Refer to SSM 75993

22-23MY Range Rover, RR Sport

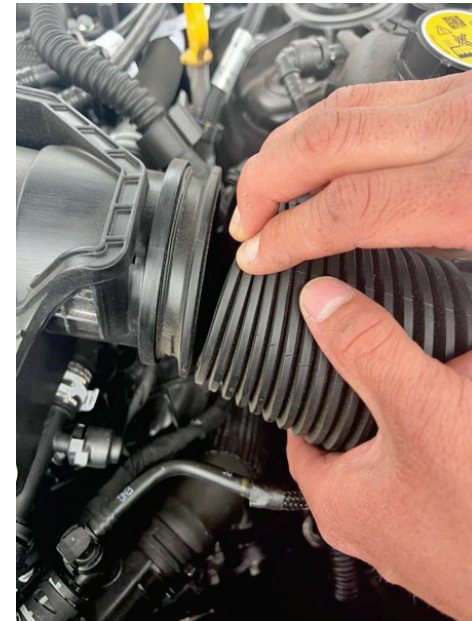
- MIL with DTC P2177-00 for lean bank 1.
- Some vehicles have been found to have damaged/torn air intake hose on the left side.

- Check left side air duct for any damage. Part number, LR157563.
- If there is a tear as shown in the attachment, please replace the intake hose and submit an EPQR referencing the SSM.
