## BODY/CHASSIS – EXCESSIVE WIND NOISE

22MY – Onwards Range Rover (L460)  
23MY – Onwards RR Sport (L461)

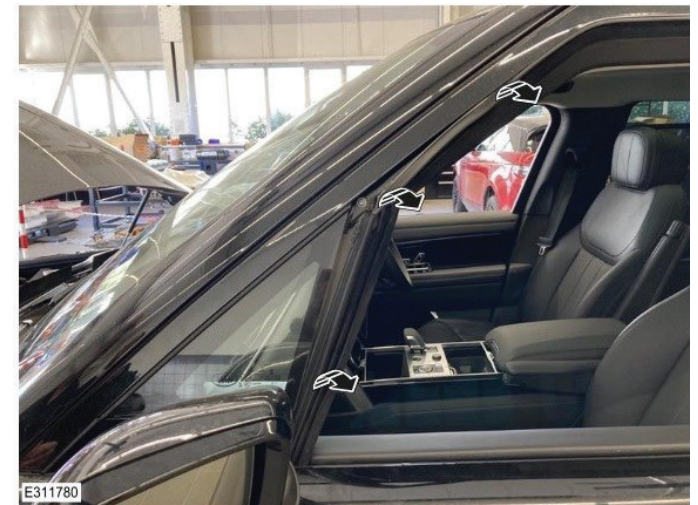
- A customer may complain of a wind noise while driving in the A-pillar/ door mirror area.

- This may be caused by airflow movement over slight gaps in body trims or seals.

- TSB JLRTB02110NAS1 is being published to address this concern.
- Should a customer express a concern, please refer to the TSB procedures for repair guidance.
