BODY/CHASSIS – CREAK TYPE NOISE FROM FRONT OF VEHICLE

20MY RR Evoque
21MY Discovery Sport

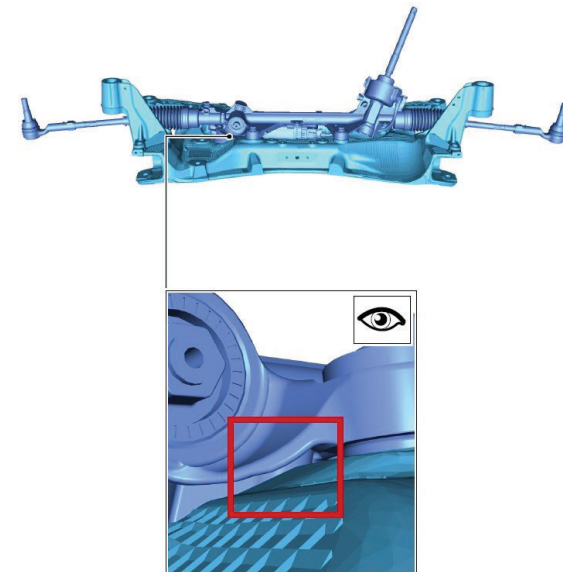
- A customer may report a creaking type noise when steering from the front of the vehicle.

- This may be caused by the steering rack contacting the front subframe at a location other than the mounting points.

- A revised front subframe machining process has been introduced to ensure proper clearance between the steering rack and subframe.
- SSM 75153 has been published to address this concern.
