TECHNICAL SERVICE BULLETIN

Classification: HA21-002E	Reference: NTB21-071E	Date: May 11, 2023
------------------------------	--------------------------	-----------------------

AUTO HVAC CENTER VENT TEMPERATURE DIFFERENCE GREATER THAN 5°C (9°F)

APPLIED VEHICLES: 2021 Rogue (T33)
APPLIED ENGINES: PR25DD

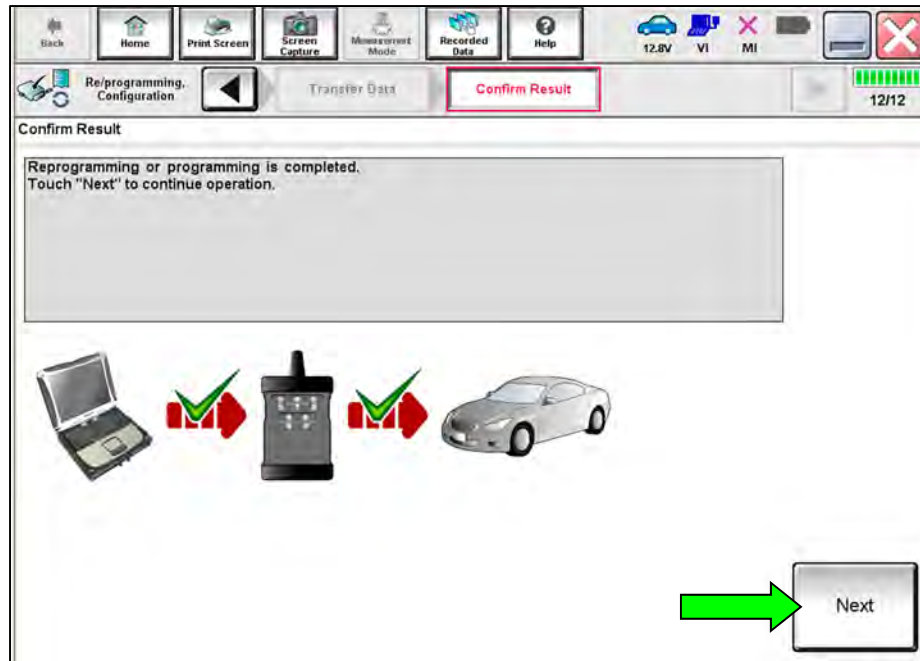
HINT: When the screen in Figure 11 displays, A/C Amplifier reprogramming is complete. If the screen in Figure 11 does not display (indicating that reprogramming did not complete), refer to the information on the next page.

21. Follow the on-screen instructions to perform **Erase All DTCs**.
22. Print a copy of the confirmation screen and attach it to the repair order for warranty documentation, and then select **Confirm**.

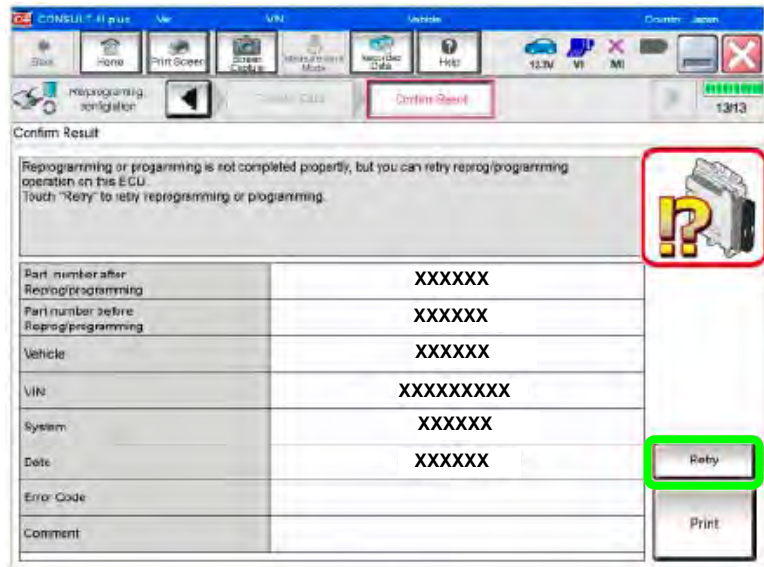
Figure 12

If reprogramming does not complete, and the “!?” icon displays as shown in Figure 12:

- Check battery voltage (12.0 V – 15.5 V).
- Ignition is ON, engine is OFF.
- External Bluetooth® devices are OFF.
- All electrical loads are OFF.
- Select retry and follow the on screen instructions.
- “Retry” may not go through on first attempt and can be selected more than once.

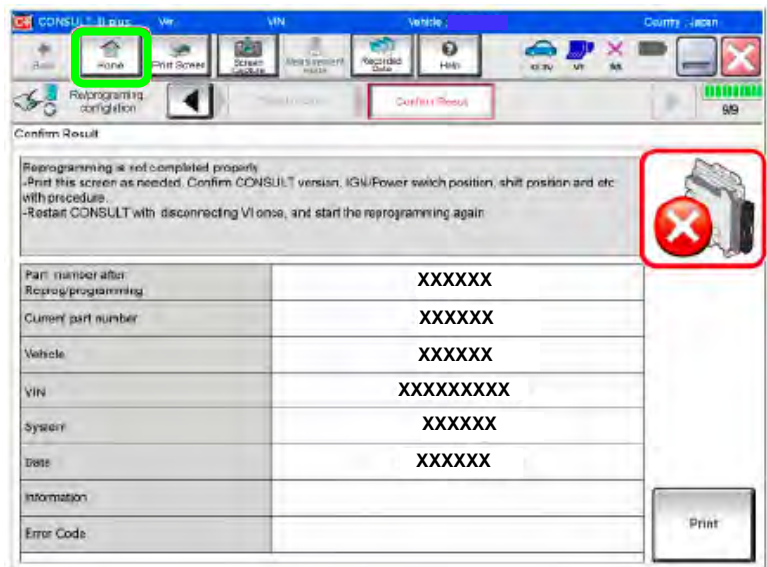
Figure 13

If reprogramming does not complete, and the “X” icon displays as shown in Figure 13:

- Check battery voltage (12.0 V – 15.5 V).
- CONSULT A/C adapter is plugged in.
- Ignition is ON, engine is OFF.
- Transmission is in Park.
- All C-III plus / VI cables are securely connected.
- All C-III plus updates are installed.
- Select Home, and restart the reprogram procedure from the beginning.
