Technical product information

New Continental GT/C

Rear spoiler does not operate - Warning message within the DIP

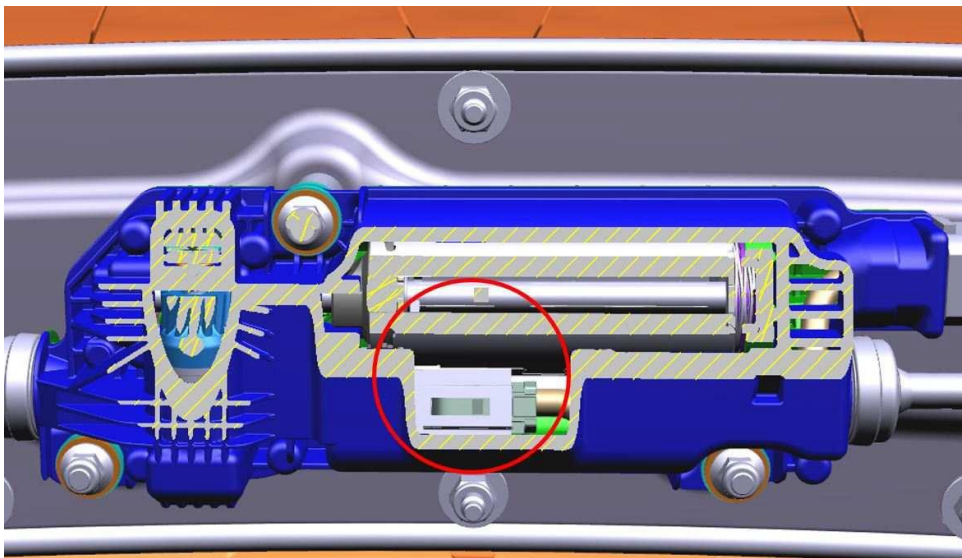
Due to the carbon brushes exerting insufficient pressure on the commutator, contact problems may occur in the electric motor for the rear spoiler drive

As a result, the electric motor does not work

Figure 2 shows the location where carbon brushes make contact with commutator

2) Should no wiring issues be evident - Referring to Rep.Gr 66 replace the deployable rear spoiler assembly
