# Technical product information

| Topic | DTC P1B8100 stored within 006B – Aerodynamic control unit - No test plan in ODIS to assist with diagnosis |
| Brand | Bentley |

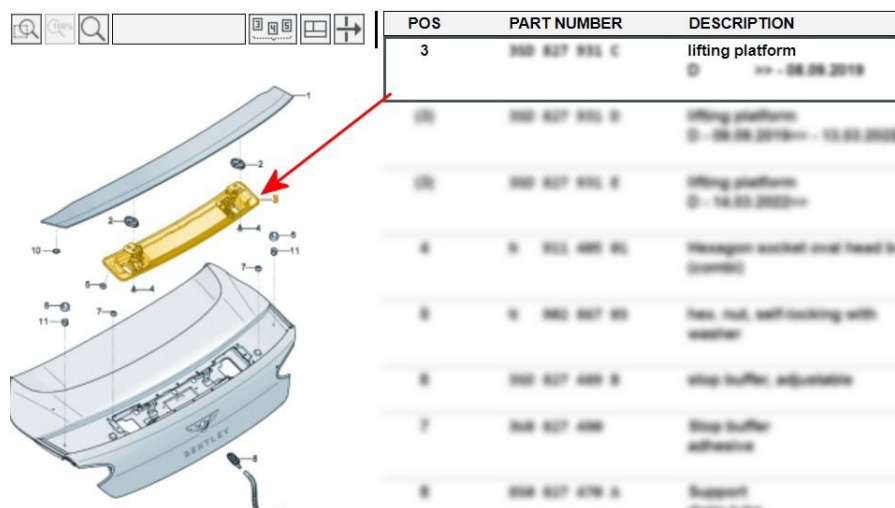
Figure 1

Refer to the ETKA parts catalogue for the deployable rear spoiler assembly (lifting platform as Figure 1) part number
