# Aftersales Field Action Bulletin

Document ID: 8-23-GL-00-003

Bulletin Title: Battery Chiller O-ring replacement & AC Compressor oil addition

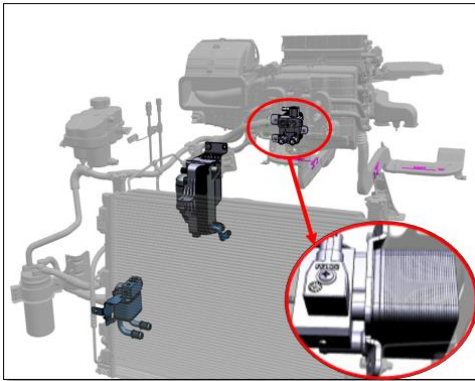
Air conditioning system lost its cooling function inside the passenger compartment due to refrigerant leak in the CHILLER zone.

The internal component O-ring sealing between the Expansion valve & Chiller is poor, which is the probable root cause for the Refrigerant leak.

**Leakage position in vehicle view - Batt Chiller**

Replace new O-rings on vehicle with increased cross-sectional thickness (for both inlet and outlet).

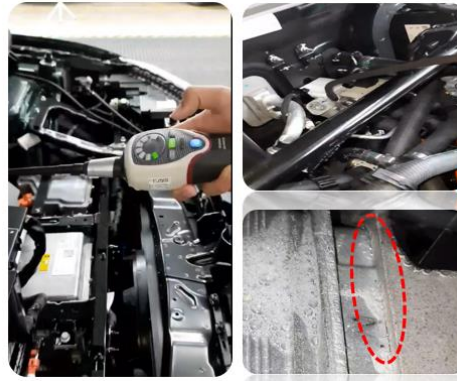
**Leakage confirmed with Sniffer and Air bubble**

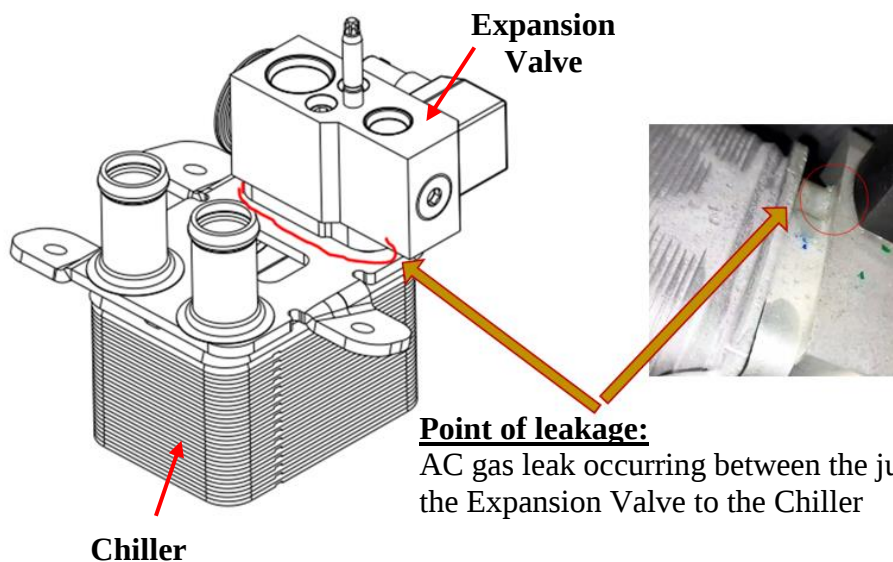
Part Number: PWT30203002

#### **Leak between Expansion Valve and Chiller**

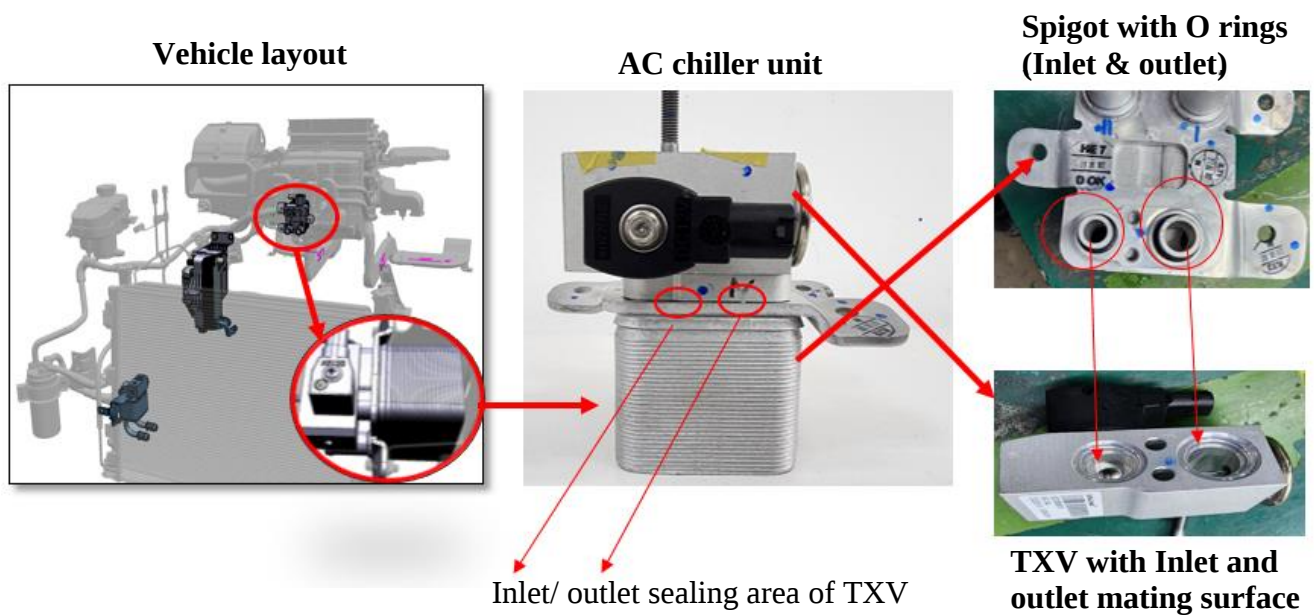
#### **Point of leakage:**

AC gas leak occurring between the junctions of the Expansion Valve to the Chiller

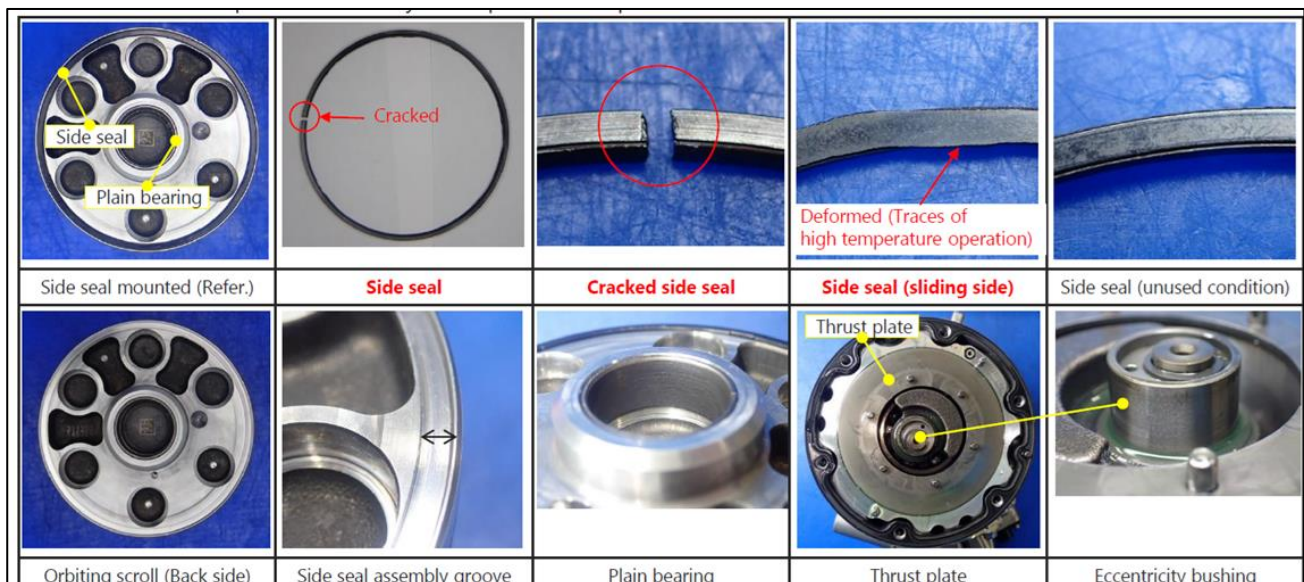
Refrigerant system compressor oil [PAG ISO 46] capacity of **120ml +/-15ml** in the vehicle is not sufficient to maintain the temperature & pressure. Therefore, after starting the vehicle, the discharge pressure raises immediately and compressor stopped by overheat.

1. Low refrigerant flow rate & poor cooling for IGBT due to circuit block.
2. Temperature rise on all sliding parts which leads to decreased strength in side seal and gets cracked.

To **add 100ml of oil** to the AC compressor in additional to 120 ml of oil, which is already presented in the compressor [Total fluid capacity in compressor: 120 ml (existing) + 100 ml (add) = 220 ml].
