# TECHNICAL SERVICE BULLETIN

Classification: DA23-001	Reference: NTB23-044	Date: May 22, 2023
-----------------------------	-------------------------	-----------------------

## FALSE ACTIVATION OF AEB OR FCW

**APPLIED VEHICLES:** 2020-2023 Titan/Titan XD (A61)  
**APPLIED SYSTEMS:** Automatic Emergency Braking/Forward Collision Warning

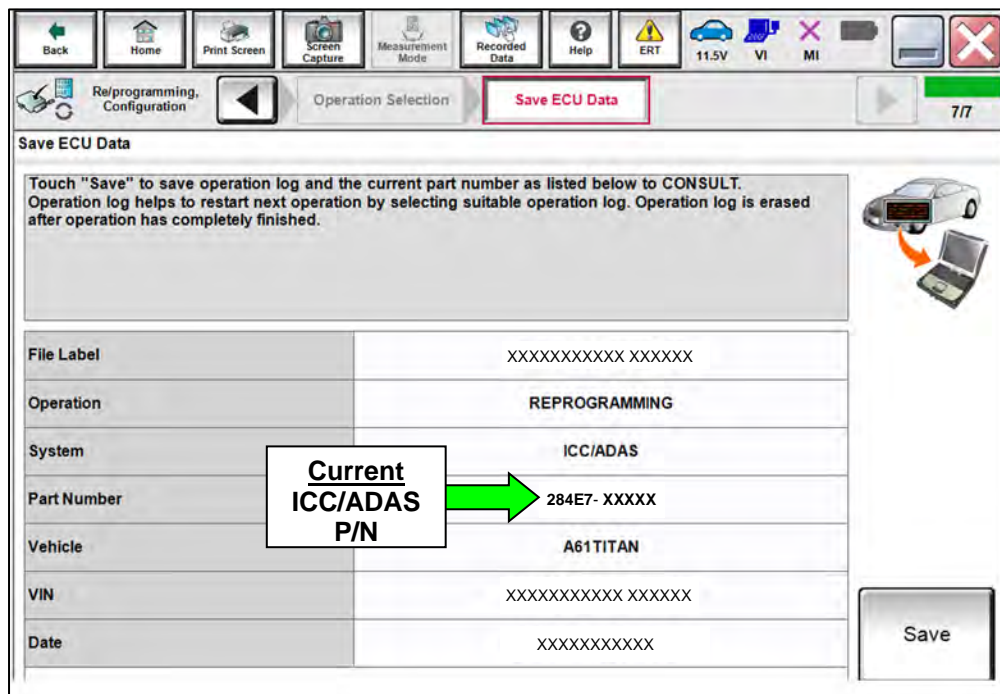
Figure 9

22. When you get to the screen shown in Figure 9, confirm that a reprogram is available as follows:

- Find the ICC/ADAS **Part Number** and write it on the repair order.

- b. Compare the P/N you wrote down to the numbers in the **CURRENT ICC/ADAS PART NUMBER** column in **Table A**.
  - o If there is a match in **Table A**, continue with the reprogramming procedure.
  - o If there is not a match, in **Table A**, this bulletin does not apply. See the ESM (Electronic Service Manual) for further diagnostic information.

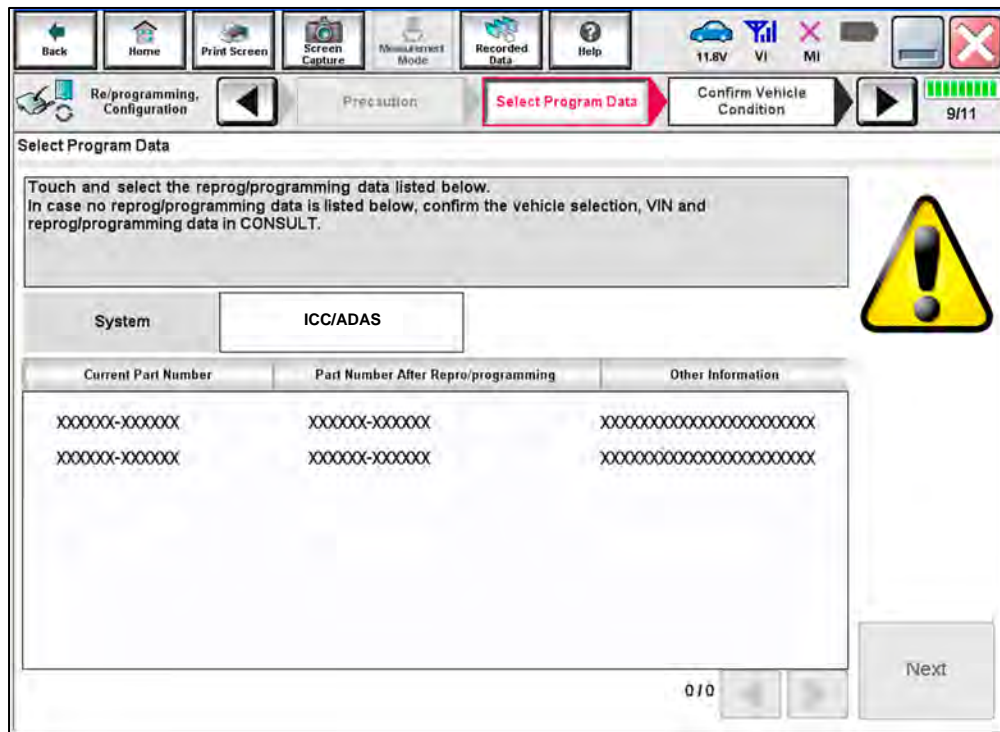
- In some cases, more than one new P/N for reprogramming is available.
  - If more than one new P/N is available, the screen in Figure 13 displays.
  - Select and use the reprogramming option that does **not** have the message “Caution! Use ONLY with NTBXX-XXX”.
- If you get this screen and it is blank (no reprogramming listed), it means there is no reprogramming available for this vehicle. Close C-III plus and refer back to ASIST for further diagnosis.

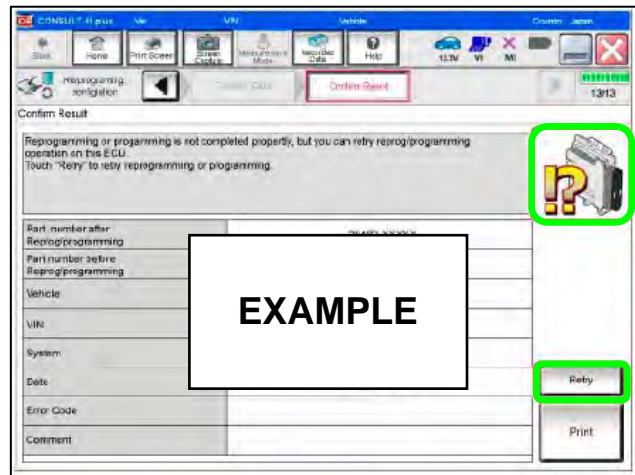
Figure 18

If reprogramming does not complete and the “!” icon displays, as shown in Figure 18:

- Check battery voltage (12.0 - 15.5 V).
- Ignition is ON, engine OFF. Or if EV in Ready Mode.
- External Bluetooth® devices are OFF.
- **All** electrical loads are OFF.
- Select **Retry** and follow the on screen instructions.
- Retry may not go through on first attempt and can be selected more than once.

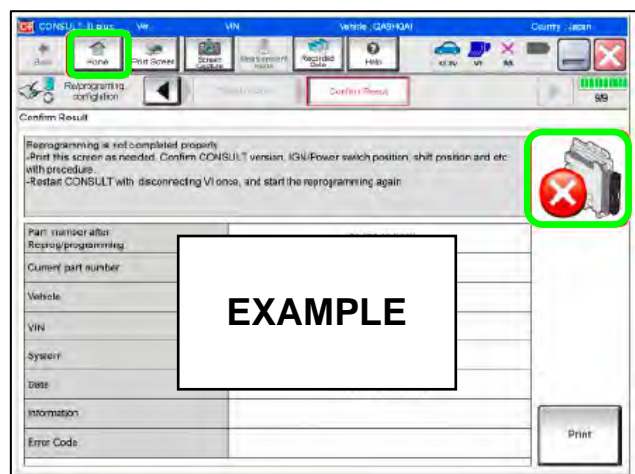
Figure 19

If reprogramming does not complete and the “X” icon displays, as shown in Figure 19:

- Check battery voltage (12.0 - 15.5 V).
- CONSULT A/C adapter is plugged in.
- Ignition is ON, engine OFF. Or if EV in Ready Mode.
- Transmission is in Park.
- All CONSULT VI cables are securely connected.
- All C-III plus updates are installed.
- Select **Home**, and restart the reprogram procedure from the beginning.

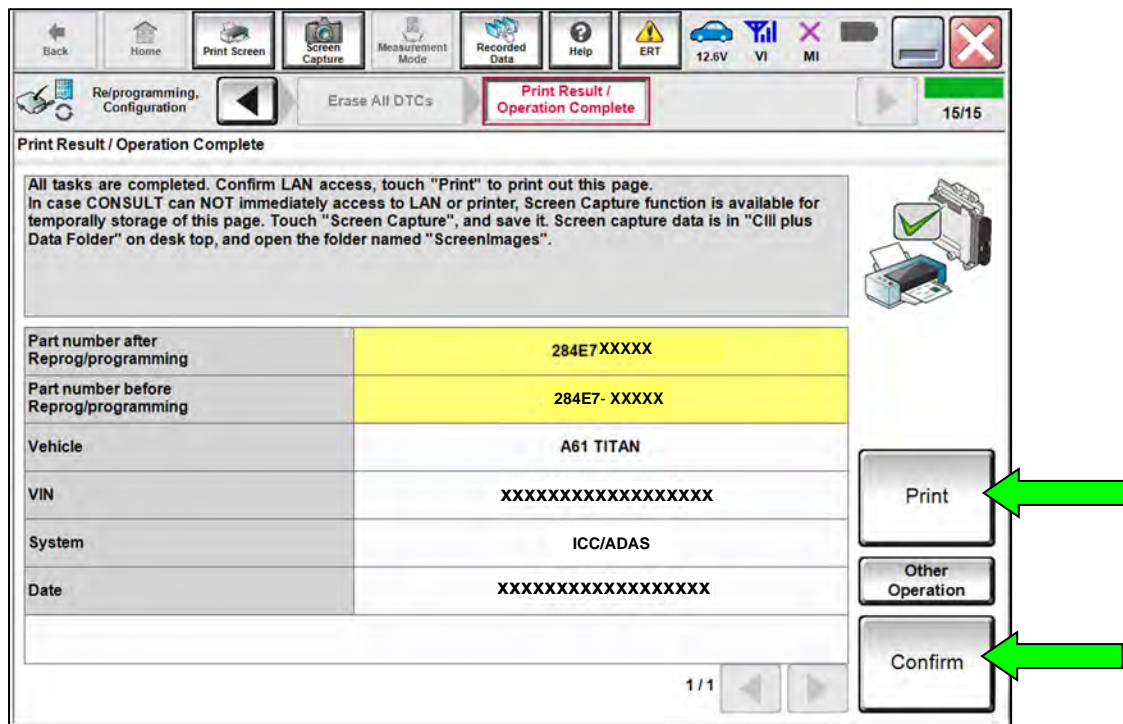
**HINT:** When the entire reprogramming process is complete, the screen in Figure 21 will display.

36. Print a copy of the screen below (Figure 21) and attach it to the repair order for warranty documentation.
