GROUP	MODEL
BOD	2022MY Stinger (CK) w/ Sunroof
NUMBER	DATE
317	June 2023

## TECHNICAL SERVICE BULLETIN

### HEADLINER NOISE REDUCTION

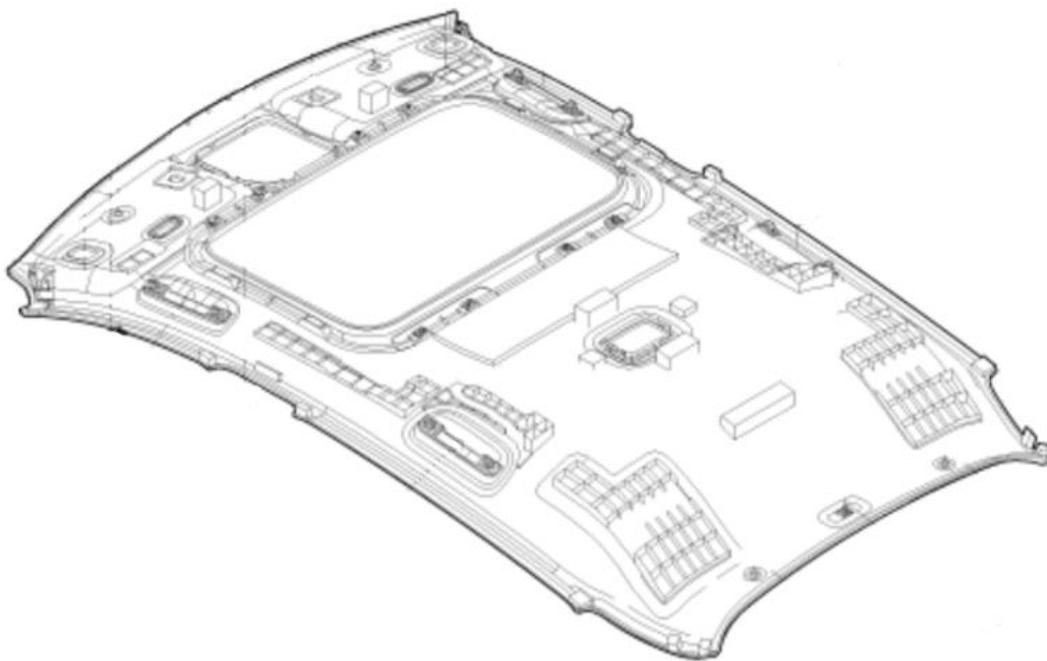
This bulletin provides information to apply anti-noise tape to the headliner and assist handle brackets on some 2022MY Stinger (CK) vehicles produced from September 9, 2021 through present, equipped with a sunroof. The affected vehicles may exhibit an intermittent noise due to normal body flexing while driving on uneven roads. Follow the procedure outlined in this publication to apply anti-noise tape to promote noise dampening.
